R22 SERVICE BULLETIN SB-118

R44 SERVICE BULLETIN SB-107

SUBJECT: Fire Extinguisher Relocation

EFFECTIVITY: R22-series and R44-series helicopters with fire extinguisher located forward of left seat tail rotor pedals.

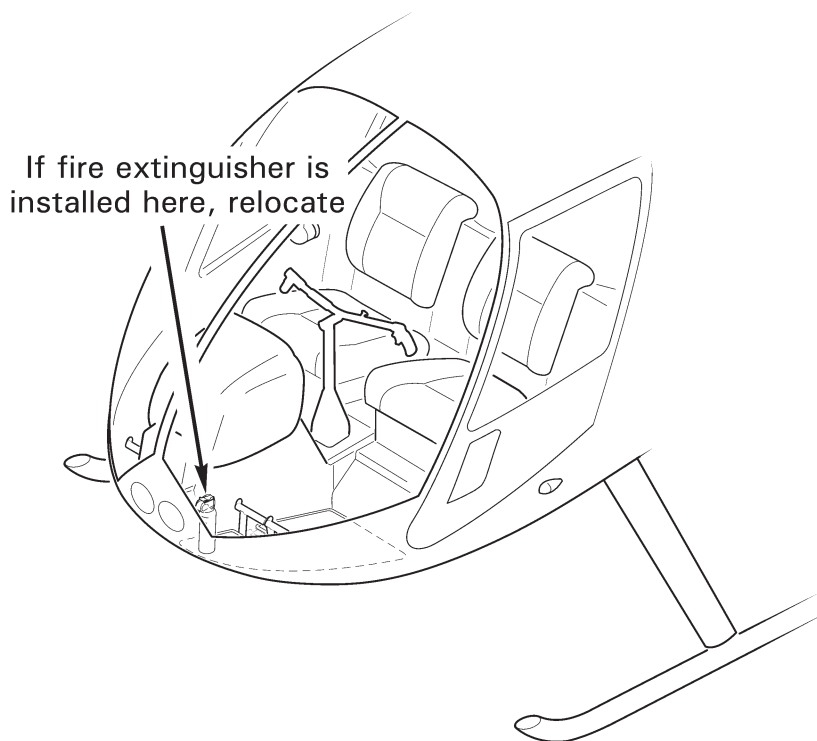
FIGURE 1

BACKGROUND: RHC has received reports of fire extinguishers either leaking charge or ejecting the top. The problems are suspected to be heat related. This bulletin requires relocating certain extinguishers to lessen heat exposure and ensure that an ejected top will not damage the windshield.

1. Refer to Figure 1. If helicopter has fire extinguisher installed in location shown, order one KI-281-1 (R22) or KI-281-2 (R44) Fire Extinguisher Relocation Kit from RHC Customer Service.

2. Relocate fire extinguisher per kit instructions.
3. Make appropriate maintenance record entries.
