**R22 SERVICE BULLETIN SB-118A**

**R44 SERVICE BULLETIN SB-107A**

**SUBJECT:** Fire Extinguisher Relocation

**EFFECTIVITY:** R22-series and R44-series helicopters with fire extinguisher located forward of left seat tail rotor pedals.

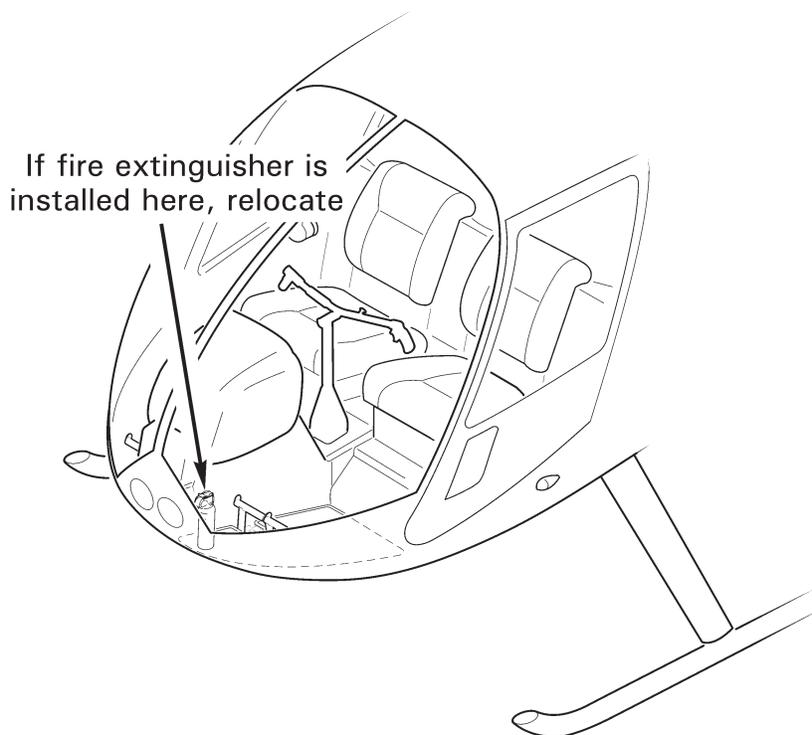
**FIGURE 1**

**BACKGROUND:** RHC has received reports of fire extinguishers either leaking charge or ejecting the top. The problems are suspected to be heat related. This bulletin requires relocating certain extinguishers to lessen heat exposure and ensure that an ejected top will not damage the windshield. Revision A corrects a part number typo on page 2.

1. Refer to Figure 1. If helicopter has fire extinguisher installed in location shown, order one KI-281-1 (R22) or KI-281-2 (R44) Fire Extinguisher Relocation Kit from RHC Customer Service.

2. Relocate fire extinguisher per kit instructions.
3. Make appropriate maintenance record entries.
