R22

SERVICE BULLETIN SB-92

DATE: 03 November 2003

SUBJECT: Tail Rotor Pedal Retaining Clips

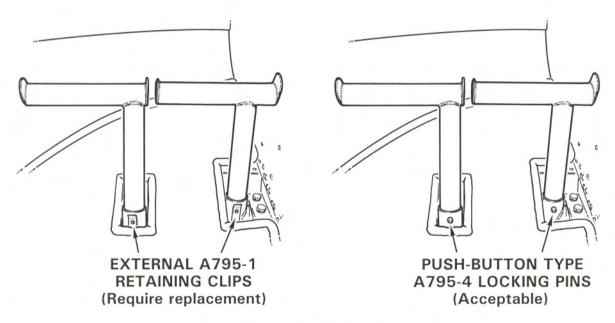
VIEW LOOKING FORWARD

ROTORCRAFT AFFECTED: R22 helicopters equipped with removable pedals secured by external retaining clips (see below), originally installed on R22s thru S/N 2373.

<u>BACKGROUND:</u> RHC has received reports of worn A795-1 retaining clips allowing removable pedals to vibrate out of position and interfere with pedal movement. This bulletin requires replacement of all external A795-1 retaining clips with pushbutton type A795-4 locking pins.

- 1. Order KI-81 kit from RHC Customer Service.
- 2. Replace retaining clips per kit instructions.
