## R22

## SERVICE BULLETIN SB-95

SUBJECT: A181-4 Lower Actuator Bearing Assembly

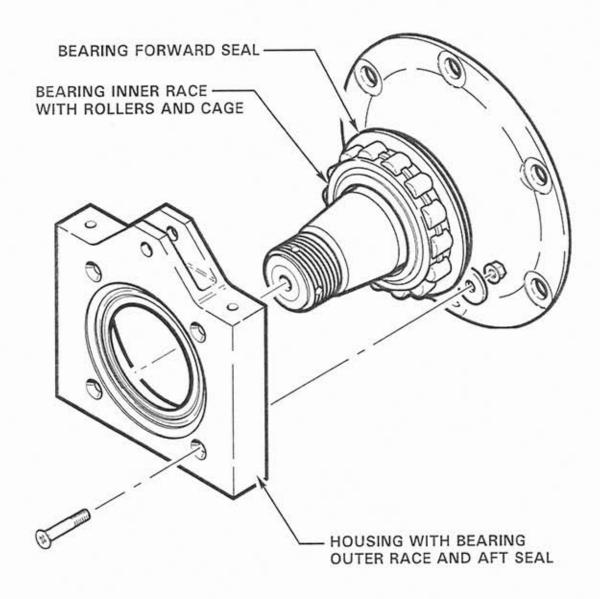
BACKGROUND: A precautionary landing was required due to a failed A181-4 lower actuator bearing. The failure occurred at low time-in-service and was caused by inadequate grease. A failed lower bearing can result in loss of power to the drive system.

- Remove fanwheel per R22 Maintenance Manual (MM) Section 6.210. Support drive line per R22 MM Section 7.510, and remove clutch actuator lower bolt.
- 2. Remove four screws securing bearing in housing.
- Separate housing from bearing as shown in figure on page 2. Some force may be required to break housing loose from forward seal.
- 4. Using clean tissue, wipe existing grease from bearing.
- 5. Lubricate bearing with 5 grams A257-12 grease. Note: 5 grams of grease fills a 1.0 inch (25mm) long space inside syringe included with RHC KI-115 kit.
- Reassemble bearing.
- Install actuator lower bolt per R22 MM Section 7.520 step (b) and fanwheel per R22 MM Section 6.220.
- 8. Make appropriate maintenance record entries.
