R22 SERVICE LETTER SL-59

DATE: 07 September 2011

SUBJECT: MRGB Oil Level Fluctuation

ROTORCRAFT AFFECTED: R22 helicopters S/N 4442 thru 4509, unless previously accomplished.

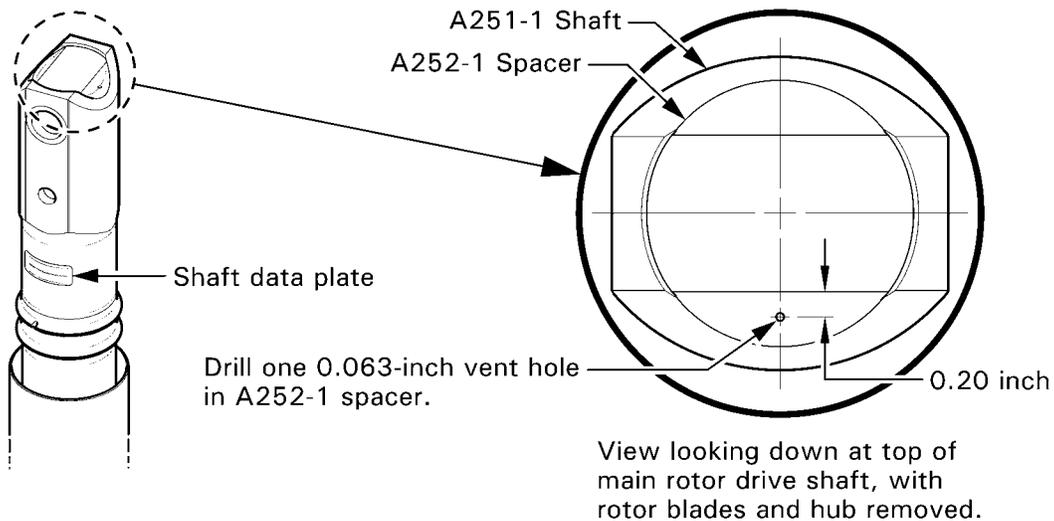
FIGURE 1

BACKGROUND: RHC has received reports of oil level fluctuating in main rotor gearboxes with sealed drive shafts. During cooling after flight, low pressure inside a sealed shaft may draw oil up into the shaft and affect oil level indication. If oil level fluctuates, a vent hole may be drilled in the aluminum spacer at the top of the shaft to equalize pressure.

1. Refer to Figure 1. If data plate indicates A251-1 shaft is revision T (or subsequent), or if A251-1 revision S (or prior) shaft's data plate is marked with a yellow paint dot, the recommendations of this letter have been complied with and no further action is necessary.

4. Refer to Figure 1. Mark hole location in A252-1 spacer as shown; remove sealant as required.
5. Vacuum debris while drilling and slowly drill 0.063-inch diameter hole thru spacer (material is 0.060 inch thick aluminum; adjust drill stop accordingly).

6. Mark shaft data plate with yellow paint dot in upper left corner.
7. Install main rotor hub per MM § 9.122.
8. Install main rotor blades per MM § 9.112.
