KI-185 Page 1 of 2

KI-185 R44 C046-18 FRAME TUBE CLAMP INSTALLATION KIT

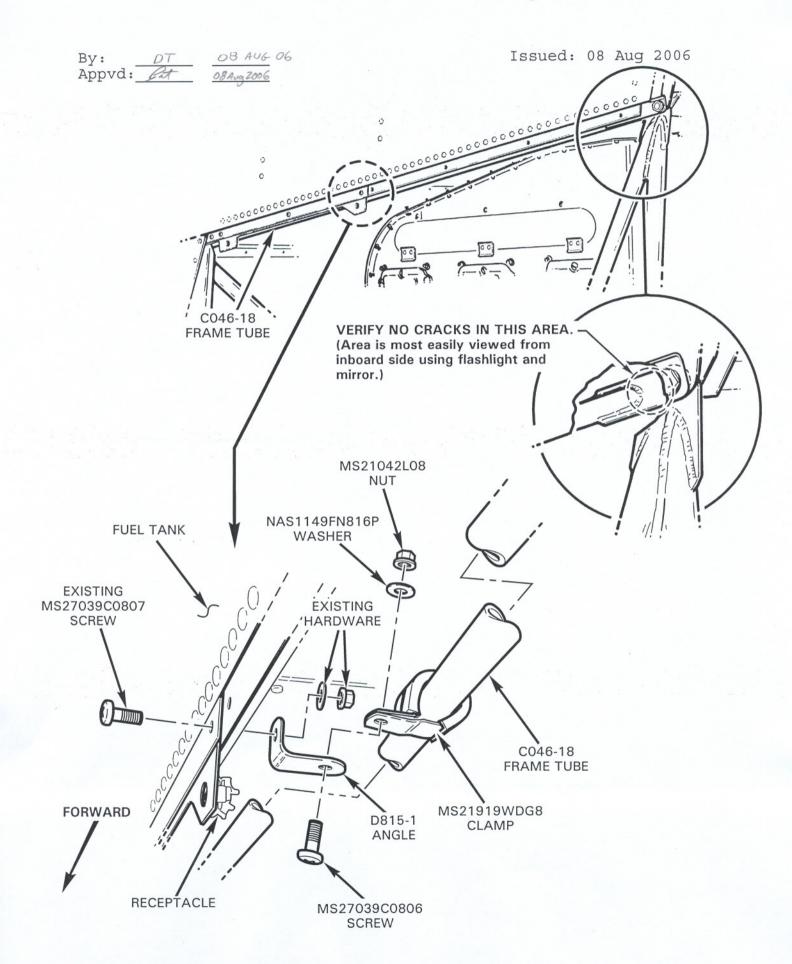
- 1. Verify kit contents match above list. Contact RHC if any parts are missing or damaged.
- 2. Remove left-side engine cowl.
- 3. Refer to figure on page 2. Visually inspect aft tab of C046-18 tube in area indicated to verify no cracks. If tab is cracked, replace C046-21 lower frame assembly or contact RHC Technical Support for repair instructions.
- 4. Remove MS27039C0807 screw adjacent to inspection door receptacle. Retain screw, washer, and nut.
- 5. Install D815-1 angle and MS21919WDG8 clamp as shown in figure.
- 6. Install left-side engine cowl.
- 7. Make appropriate maintenance record entries.
