# Robinson Helicopter Company

## MANDATORY SERVICE BULLETIN B-4

ROTORCRAFT AFFECTED: Robinson Model R22

SUBJECT: Dye penetrant inspection aft end of upper steel tube frame assy. P/N A020-2.

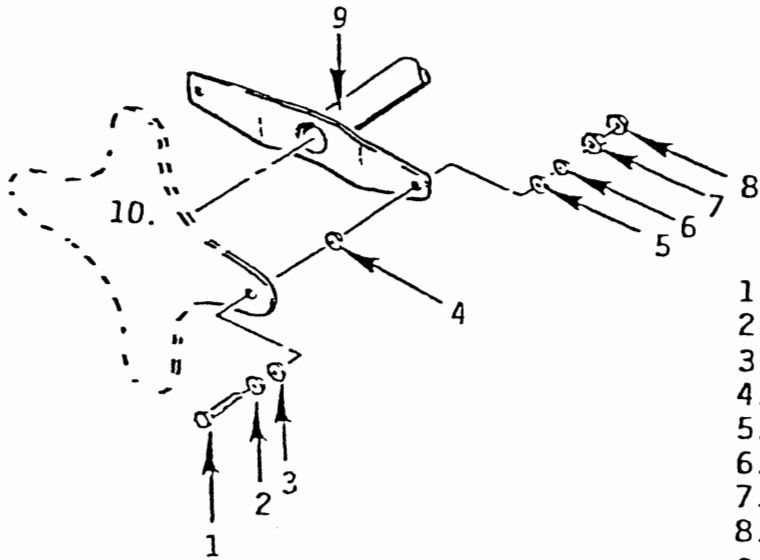
FIG. 1

NOTE: On reassembly the bolt head is always on the flexplate side of the installation. See fig. #1.

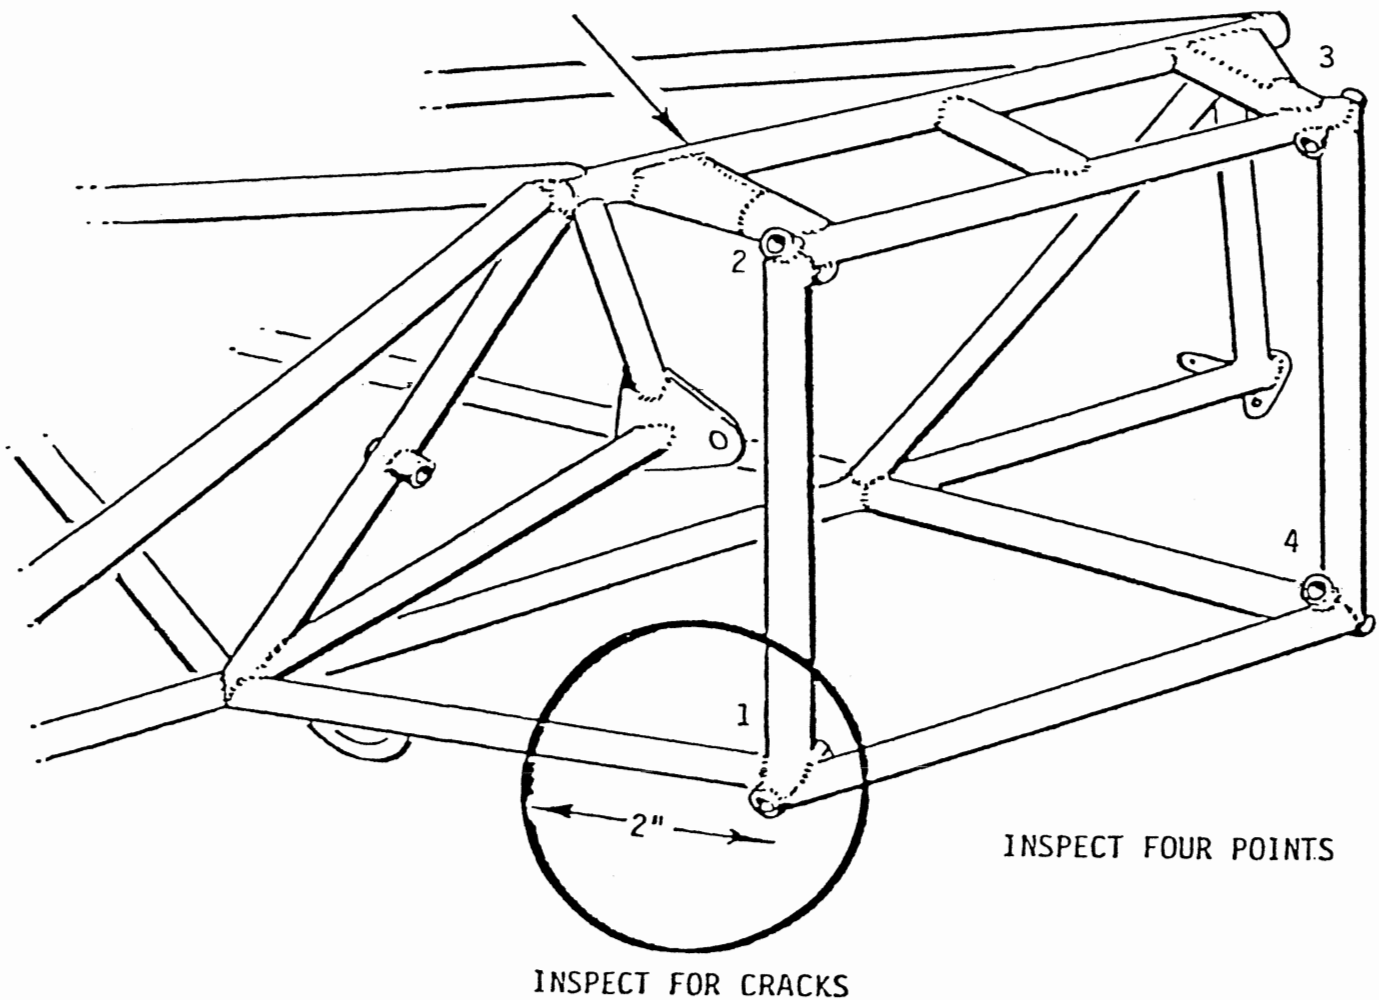
FIG. 2

BACKGROUND: Small cracks in the steel tube structure at the tail-cone attachment have been found in the prototype R22 and the first production aircraft at its 1000 hour inspection. To check for possible cracks in this area on other aircraft, the following inspection must be completed every 100 hours.

5. Carefully check for cracks in and around each weld bead and along each steel supporting tube for at least two inches away from the weld beads. It is unlikely a crack will be found; however, should one occur, call R.H.C. Customer Service at 213/539-0508 for further instruction.

INSPECT FOUR POINTS

INSPECT FOR CRACKS

CORRECTIVE ACTION: Any frame which is cracked must be returned to the factory for repair or replacement.
