Robinson Helicopter Company

MANDATORY SERVICE BULLETIN

SUBJECT: Ice Blockage of Engine Breather Tube

ROTORCRAFT AFFECTED: R22 Serial No. 0002 thru 0100

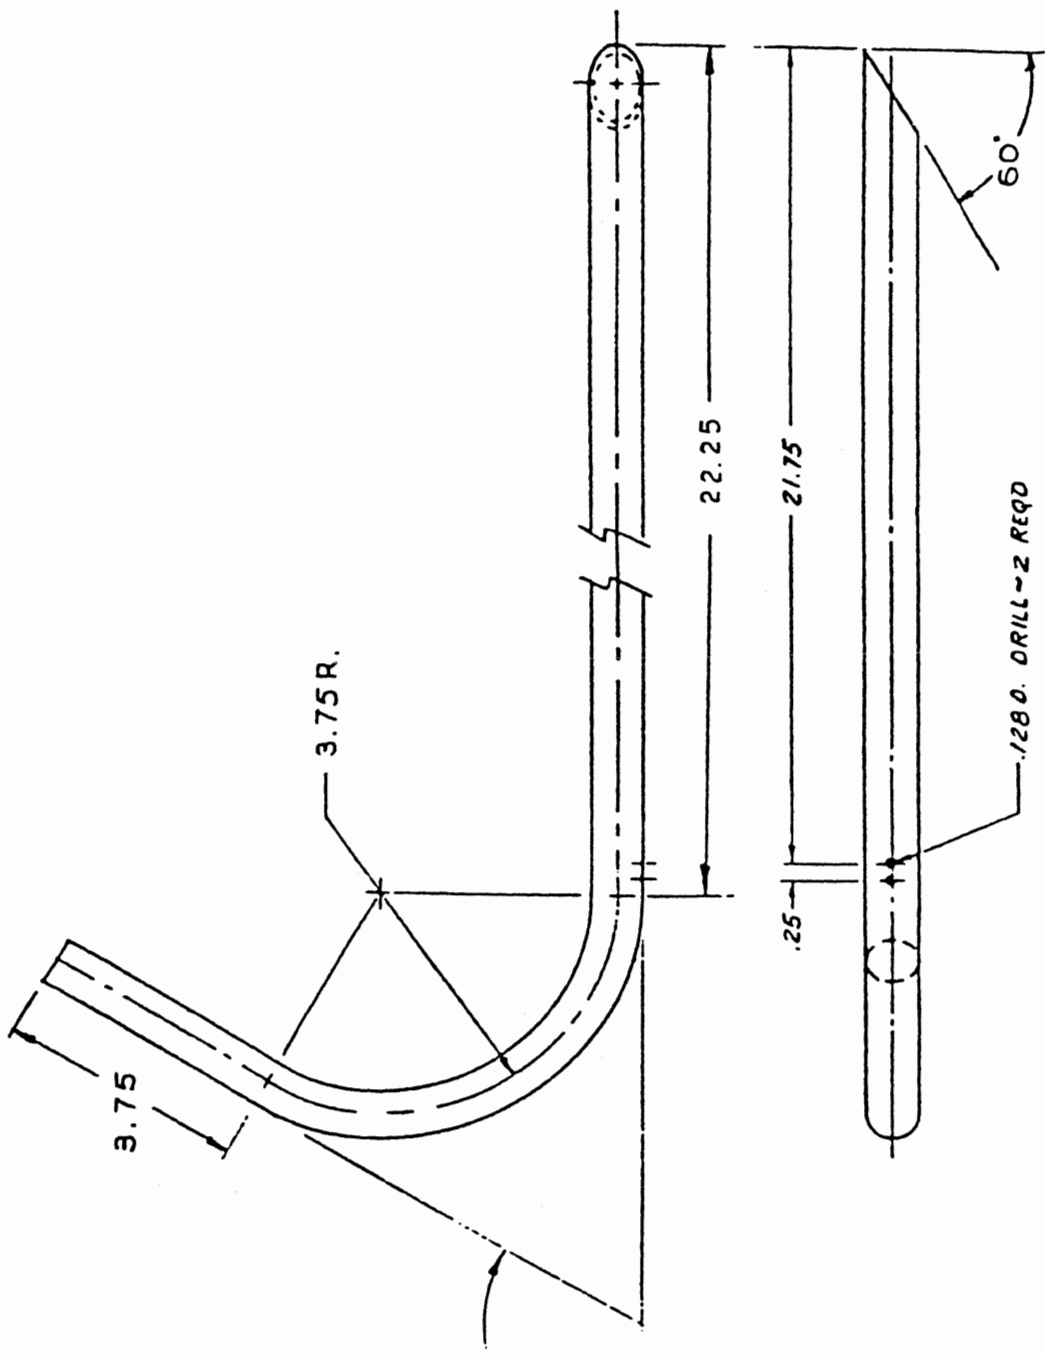
BACKGROUND: A case has been reported where ice blocked the lower end of the engine crankcase breather tube. The resulting pressure buildup blew out the crankshaft nose seal, causing loss of engine oil pressure.

- 1) Remove the right-hand engine compartment panels.
- 2) Locate the engine breather vent tube. The tube is 3/4" in diameter and gray in color, with a 60° angle cut facing aft at the lower end which protrudes below the fuselage at the forward end of the engine compartment.
- 3) Drill two 1/8" holes in the tube 1/4" apart just below the bend in the upper portion of the tube as shown on the attached sketch.
- 4) Deburr holes and replace the right-hand panels.
