**R22 SERVICE BULLETIN SB-103A**

**DATE:** 30 April 2010

**SUBJECT:** Main Rotor Blade Bond Inspection

**ROTORCRAFT AFFECTED:** R22-series helicopters with A016-4 main rotor blades.

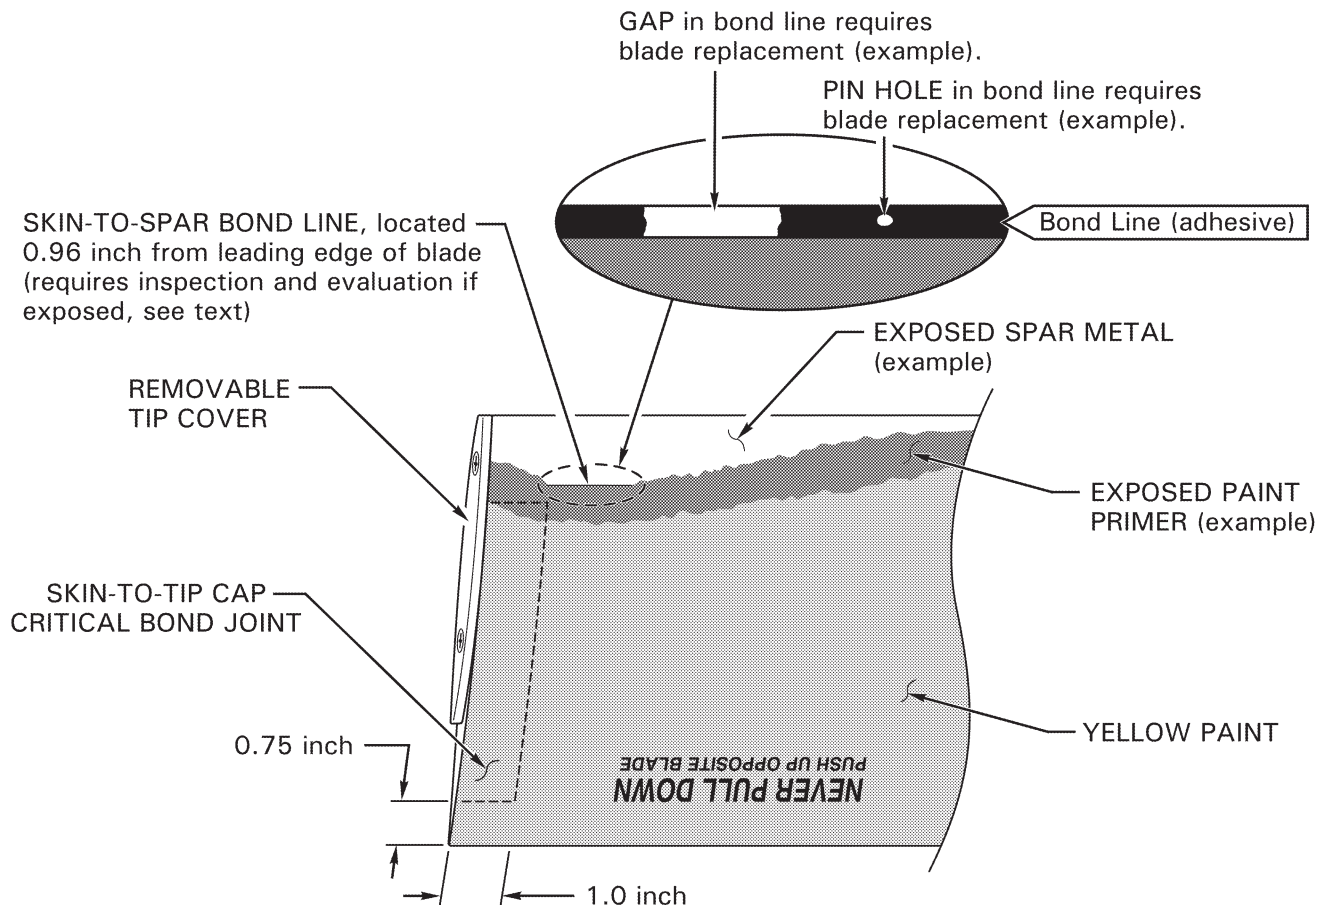
**BACKGROUND:** Debonding of rotor blade skins can occur when the bond line is exposed due to erosion of the blade finish, or when corrosion occurs on the internal aluminum tip cap. Proper inspection and protection (refinishing) of bonded areas is required. Debonding resulting from improper inspection and maintenance could cause a catastrophic accident.

**FIGURE 1 TIP AREA AND LOWER SURFACE**  
(Example, Blade with Excessive Paint Erosion)

1. Refer to Figures 1 and 2. Remove both main rotor blade tip covers and clean the blades. Clean and remove any corrosion from tip covers.
2. Using 10x magnification, visually inspect uncovered skin-to-tip cap bond joints. Using a 1965-or-later United States quarter-dollar coin, tap test skin-to-tip cap bond joints on both upper and lower surfaces. If corrosion, separation, or voids are detected, blade is unairworthy. A tap test tutorial video is available on our website, [www.robinsonheli.com](http://www.robinsonheli.com), under the Publications tab.
3. Using 10x magnification, visually inspect any exposed skin-to-spar bond line for gaps (empty space between skin and spar). Blade is unairworthy if any gap, including "pin hole(s)", is detected in the bond line.
4. Refer to Figure 2. Mark outboard 120 inches of blade lower surface as shown to identify skin-to-spar bond joint area.

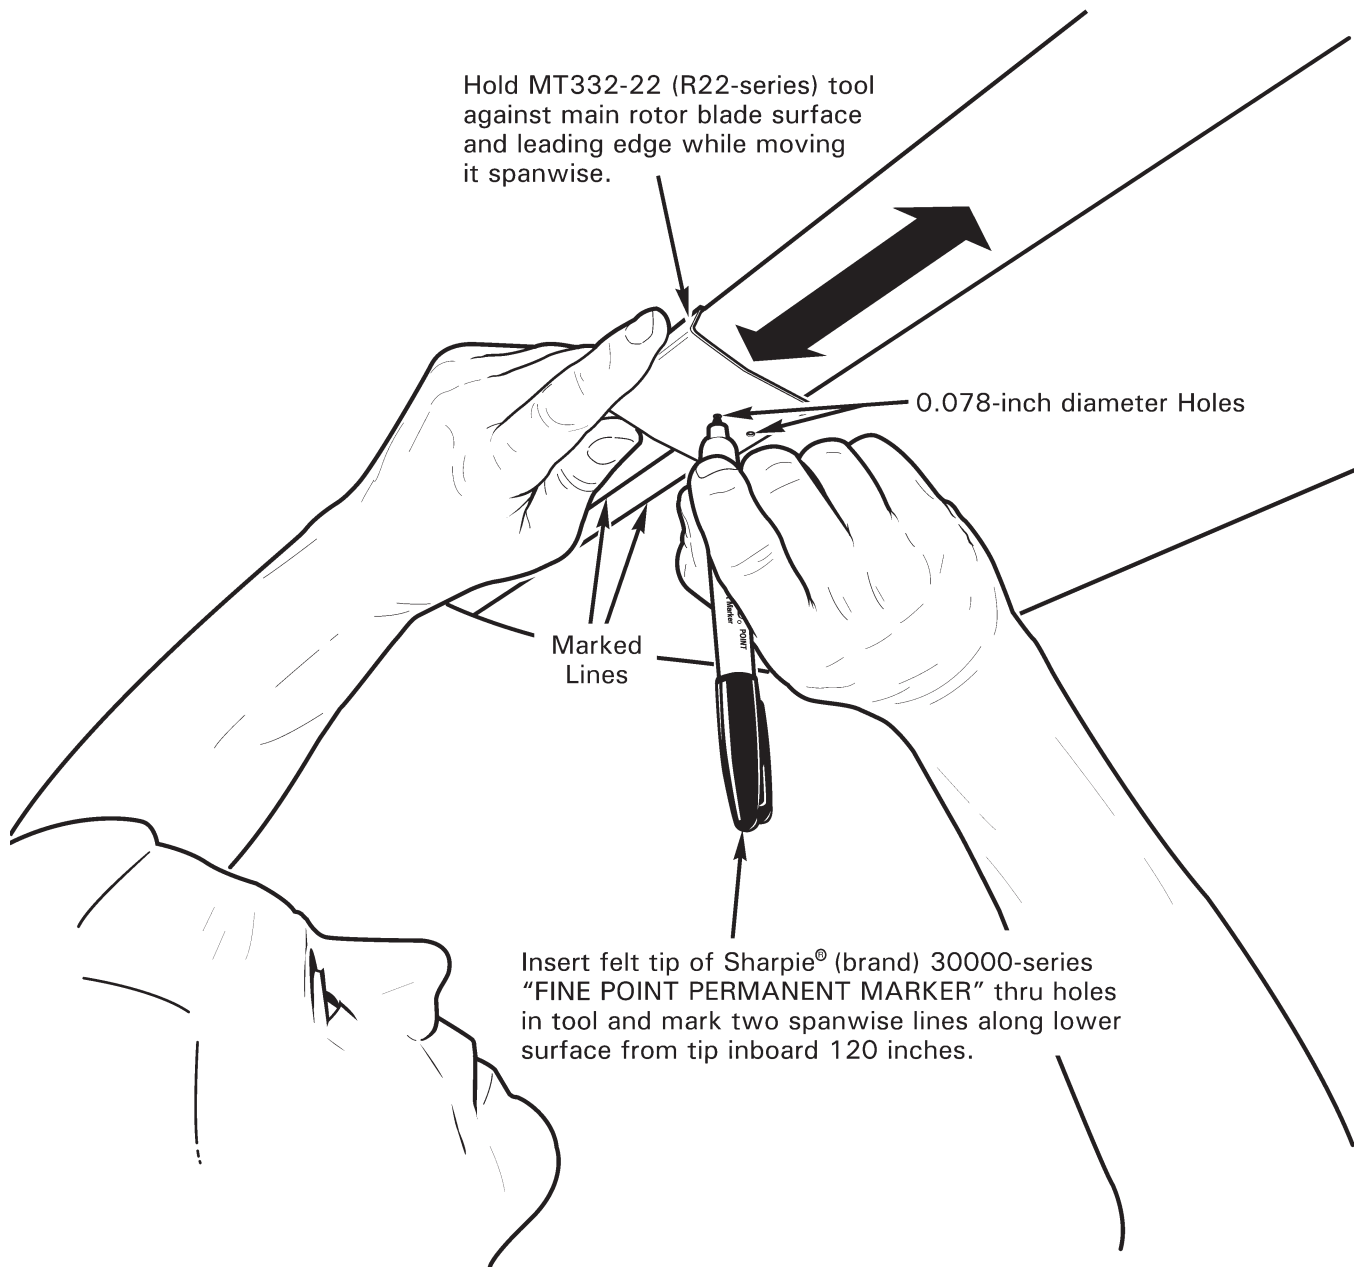
FIGURE 2 MARKING LOWER SKIN-TO-SPAR BOND JOINT AREA

5. Verify no visible dents within the bond joint area. Blade is unairworthy if bond joint area is dented.
6. Tap test the lower skin-to-spar bond joint and verify no voids exist. Blade is unairworthy if a void is detected.
7. Refinish all exposed bare metal, including tip covers, per R22 SL-56B.
8. Install blade tip covers.
9. Make appropriate maintenance record entries.
