Robinson Helicopter Company

MANDATORY SERVICE BULLETIN #14

SUBJECT: Failure of the A041-2 damper clip

ROTORCRAFT AFFECTED: R22 helicopters, Serial Numbers 0002
thru 0220

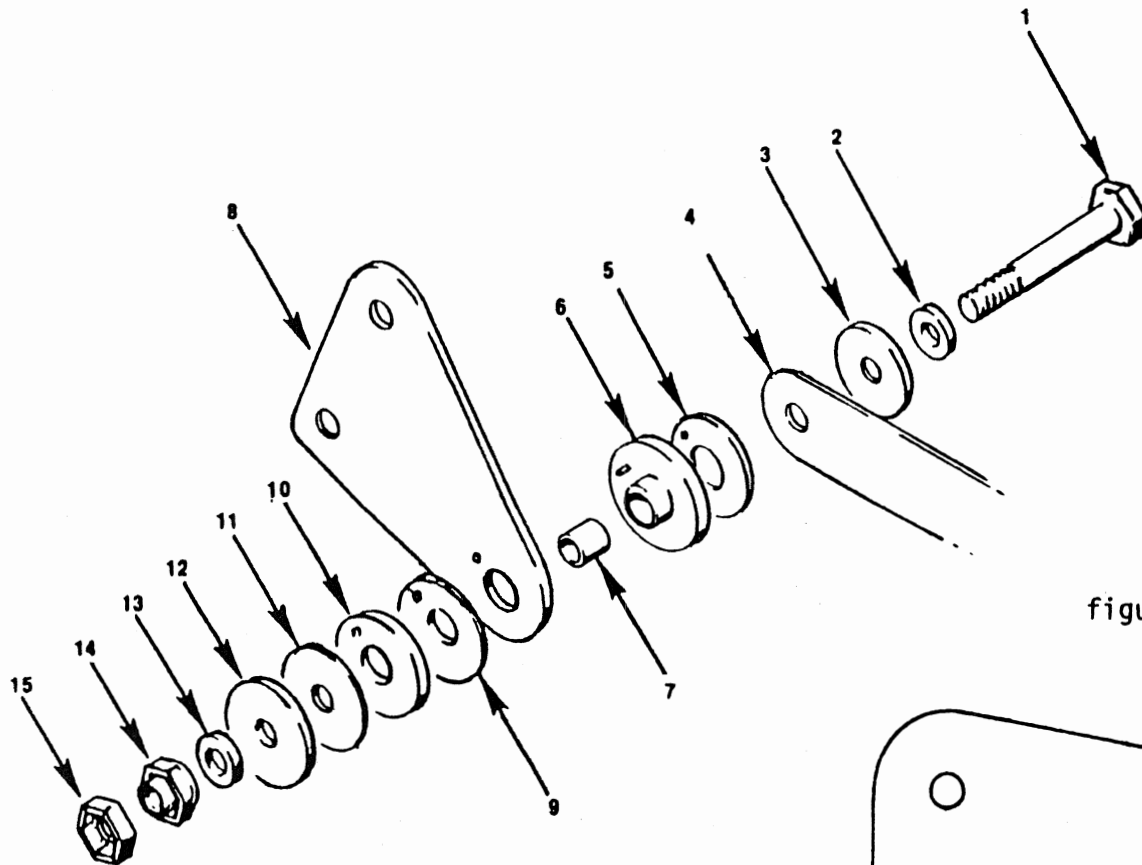
figure 1

BACKGROUND: There have been two reported incidents of Tail Rotor drive shaft damper clips (part number A041-2) fracturing in flight after suspected overspeeds. The fractured damper clips allowed the drive shaft to whip inside the tailcone. Safe landings were made. However, a fracture of the damper clip could cause failure of the Tail Rotor drive shaft and loss of directional control.

8. Remove the Tail Rotor drive shaft from the tailcone.
9. Carefully disassemble and reassemble the damper per the following steps for the A041-2 clip replacement (see fig. 1).

- a) Remove items 9 thru 15 in figure 1.
 - b) Remove the A041-2 aluminum clip and replace with the A041-2 steel clip enclosed with this bulletin.
 - c) Reinstall items 9 thru 15.

Be sure the small dowel pin is lined up with the holes in items 8, 9, and 10 before tightening nut.

- d) Torque the NAS679-A3 nut to 35 to 40 in-lbs. Hold the A041-3 arm (item 4) and attach a spring scale or dead weight to one bolt hole in the A041-2 clip (item 8). It should take 1 to 2 lbs. to move the clip.

If drag is less than 1 lb., check the A041-6 spring washer (item 9) and bend washer until it has a total height of .070 \pm .010 inch. If the spring washer is OK, but the drag is still too low, sand metal from the end of the A105-9 journal (item 7). If drag is greater than 2 lbs., flatten washer slightly.
