Robinson Helicopter Company

MANDATORY SERVICE BULLETIN #18

Subject: Inspection of A020-2 Upper Steel Tube Frame.

Rotorcraft affected: All R22 rotorcraft S/N 0002 thru S/N 0260
having A020-2 Steel Tube Frames S/N 0002
thru S/N 0287 installed.

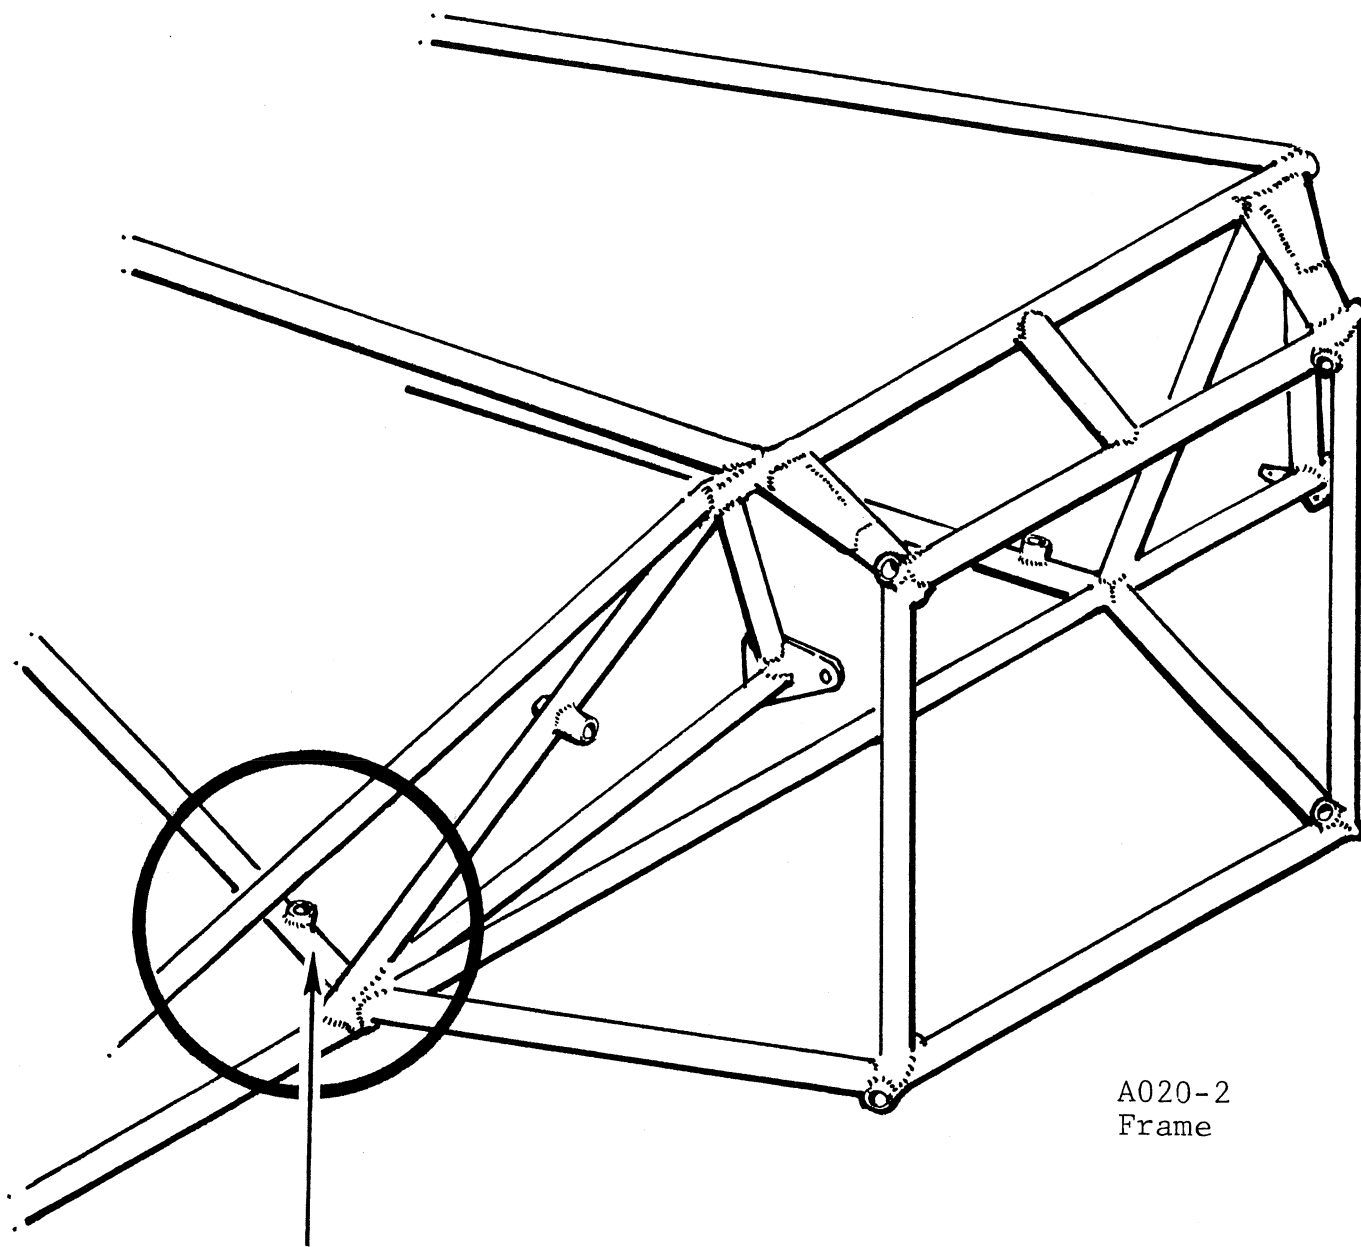
Figure 1

Background: Fatigue cracks have been found on two A020-2 Upper Steel Tube Frames at the location pictured in Figure 1. The inspection detailed below must be performed every 50 hours to detect possible fatigue cracks. This inspection may be performed by a licensed pilot at the 50 hour interval between 100 hour inspections after careful checkout by a licensed mechanic.

Inspect for Cracks
at this location

- 1) Using a 10 power magnifying glass and a high intensity light, visually inspect the welded area on the Upper Steel Tube Frame at the location indicated in Figure 1.
- 2) Make a logbook entry after every 50 hour inspection. The mechanic or pilot must verify the inspection was performed by using his name and Airman's certificate number.
- 3) Pilots must also include a visual check of this area in their daily preflight check. The inspection light and 10 power magnifying glass is not required for the daily preflight check.
- 4) If a crack is found, remove the Steel Tube Frame from service and contact:
