ROBINSON HELICOPTER COMPANY

SERVICE BULLETIN #39

SUBJECT: Drilled head bolt installation lower LH frame to fuselage

ROTORCRAFT AFFECTED: R22 Serial No. 0002 through 0383

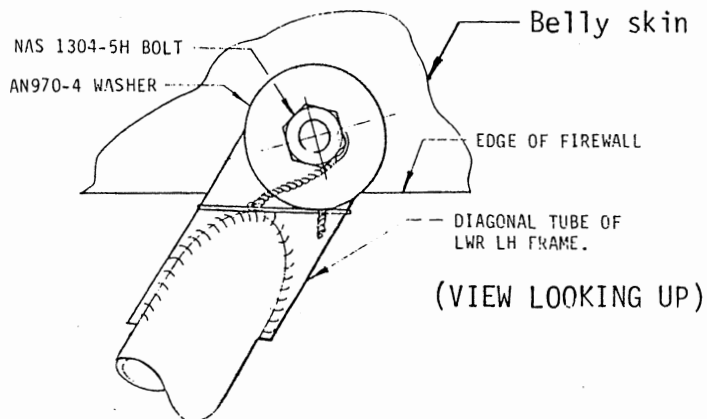
BACKGROUND: The left frame diagonal tube is attached to the belly of the fuselage with an NAS 1304 bolt. There have been reports of this bolt loosening in flight. To prevent this, the existing bolt is being replaced with a drilled head bolt and safety wired to the frame.

1. Remove NAS 1304 bolt from diagonal tube of lower left hand frame at fuselage attach point.
2. Install NAS 1304-5H bolt with AN 970-4 washer under head.
3. Torque bolthead 100 in-lb. plus drag.
4. Safety wire bolthead to diagonal tube of frame with MS20995C .032 wire, running one loop around the frame.
5. Torque stripe bolthead to fuselage.
