# ROBINSON HELICOPTER COMPANY

## SERVICE BULLETIN #53

SUBJECT: Cracks in Lower Vertical Fin Attachment Channels.

ROTORCRAFT AFFECTED: S/N 0002 thru S/N 0598

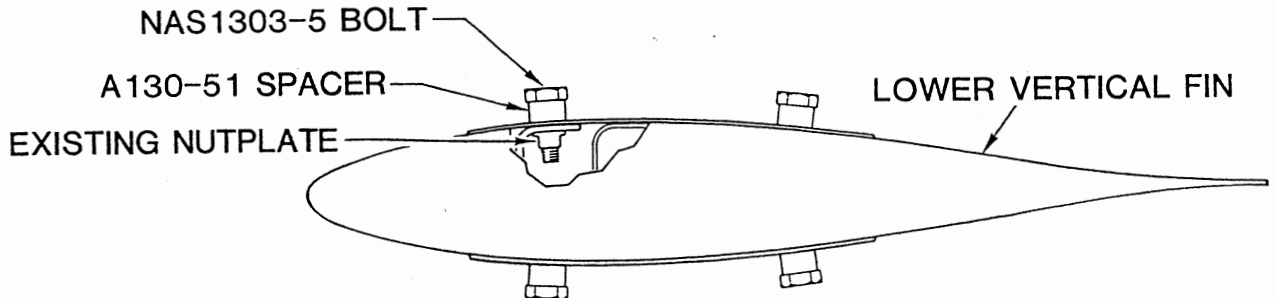
Fatigue cracks have been found in horizontal stabilizer channels near the nutplates which attach the lower vertical fin. In one case the fin separated inflight causing a serious accident.

The fatigue cracks are caused by a combination of one or more of the following:

- a) Idling at 60 to 65% RPM so the stabilizer and fins are in resonance with the tail rotor.
- b) Tail rotor out-of-balance.
- c) Tail rotor teeter hinge bearings worn and loose allowing tail rotor to go out-of-balance.
- d) Insufficient clamping from bolts attaching vertical fins to horizontal stabilizer allowing fretting to occur in the joint.

6. Reinstall the vertical fins using the bolts and spacers in the RHC KI-52 kit on the lower fin as shown below. Torque the NAS 1302-2 & -5 bolts on both fins to 60 inch pounds plus locking torque for optimum clamping.
