SERVICE BULLETIN #57

DATE: 11 May 1987

SUBJECT: Main Rotor Pitch Link Inspection & Fitting Replacement

ROTORCRAFT AFFECTED: All R22 Helicopter S/N 0580 Thru S/N 0644.
All R22 helicopters overhauled or repaired at RHC completed between 15 August 1986 and 7 May 1987.
All pitch link spare parts A258-1, -2, or -4 received from RHC between 15 August 1986 and 7 May 1987.

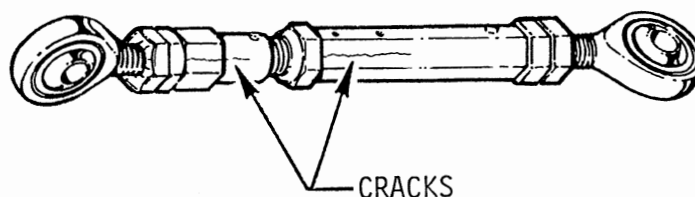
FIGURE 1 CRACK LOCATION

Flaws have been found in the material used during a production run of the A258-2 and -3 pitch link components. These flaws produce lengthwise cracks in the parts and, if allowed to progress, these cracks could lead to failure of the pitch link and loss of control of the helicopter.

1. Visually inspect the Main Rotor Pitch Links for cracks using 3X or greater magnification. Pay particular attention to any crack or crack-like indication that runs lengthwise of the A258-2 upper fitting or the hexagon shaped A258-3 lower link.

2. If any crack indications are found, immediately ground the helicopter and perform Part B prior to any further flight.
3. Part A may be accomplished by a pilot or mechanic and must continue until Part B is accomplished.

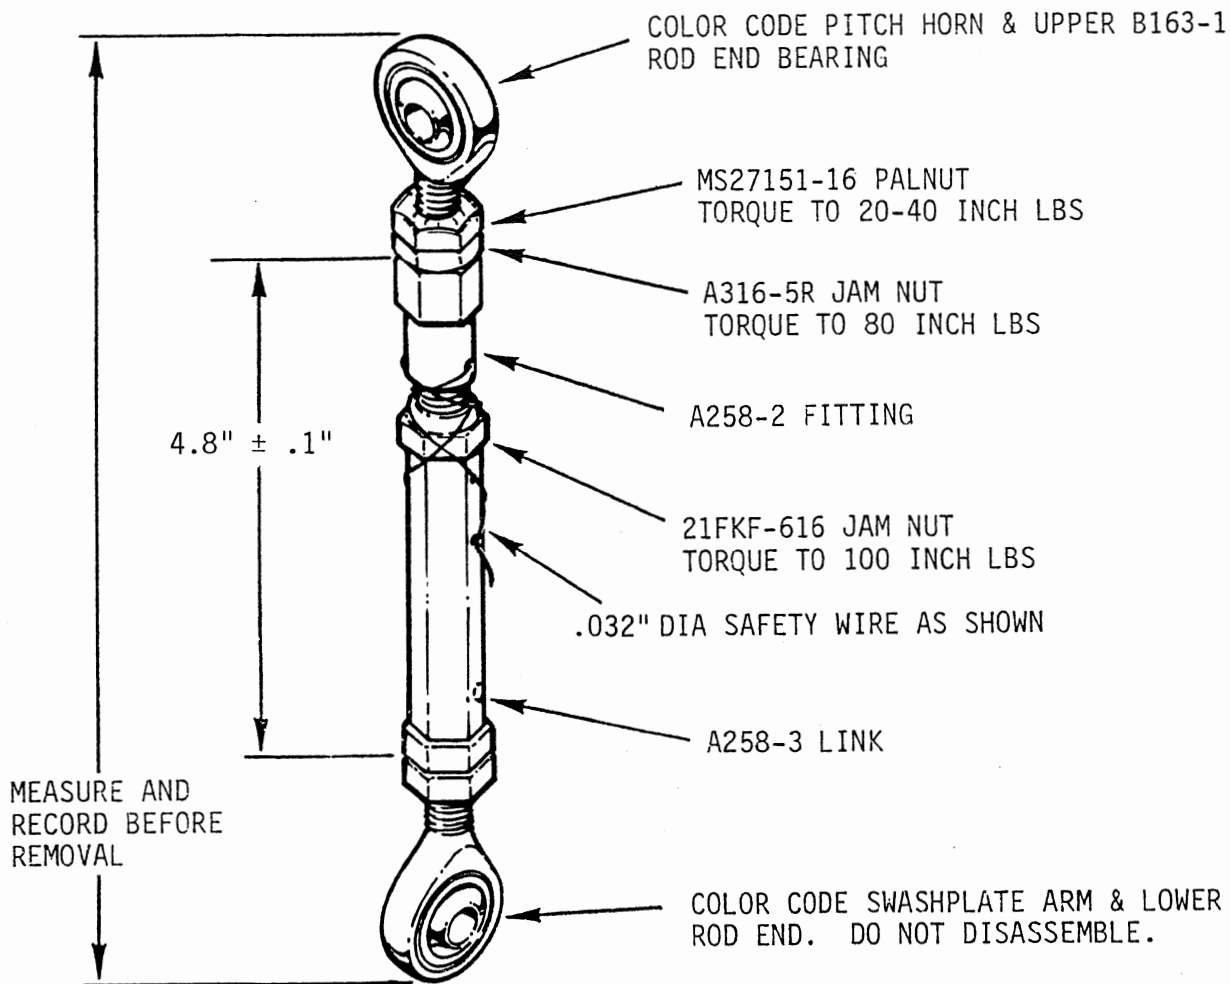
FIGURE 2 MAIN ROTOR PITCH LINK

COLOR CODE BEFORE REMOVING FROM HELICOPTER

1. Order replacement A258-2 Fittings from RHC, two required per aircraft.
2. When replacement parts are received, install per Steps 3 thru 10.
3. Color code swashplate arms, pitch horns, and both pitch link rod end bearings.

4. Remove pitch links and measure overall length using a caliper or large micrometer. Record length to nearest .001 inch.
5. Disassemble pitch links. Do not remove lower rod end bearing. Replace A258-2 fittings.
6. Remove paint and visually inspect the A258-3 links using a 3X or greater magnification; if any crack indications are found, replace complete A258-1 Pitch Link assembly.
7. Red tag replaced Fittings and any defective Links and return to RHC for warranty credit.
8. Reassemble pitch links as shown in Figure 2. Keep overall length to within $\pm .005$ of length measured before disassembly.
9. Install on helicopter and torque attaching bolts to 100 inch-lbs. See Section 8-412 of Maintenance Manual.
10. Touch up paint using an epoxy primer and grey exterior paint. Torque strip all joints. Final inspect and make appropriate log book entry.
