ROBINSON HELICOPTER COMPANY

SERVICE BULLETIN #60A

DATE: 30 November 1988 REVISED: 13 Jan. 1989
TO: All R22 Owners, Operators and Service Centers
SUBJECT: Main Rotor Spindle Rework & Journal Replacement

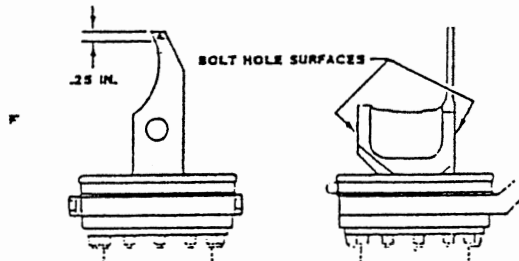
BACKGROUND: As described in SB-59, a crack was found in an R22 Main Rotor Spindle. Examination of the crack indicated that it originated in a fretted contact area between the A158 Spindle and the edge of the A106 Stainless Steel Journal. Such fretting can significantly reduce the fatigue strength of the affected metal surface.

1. Remove both main rotor blades per Section 9.111 of the R22 Maintenance Manual. Clean, visually inspect with a 10X magnifying glass, and Dye Penetrant Inspect both bolt hole surfaces (see sketch). If any crack indication is found, immediately remove from service and notify the RHC factory. Visually inspect surfaces for nicks, scratches, pits, or excessive fretting. If surface defects greater than .0005 inch deep are found, Spindle must be returned to RHC for repair or replacement.
2. Polish bolt hole surfaces with 220, 320 and 400 grit abrasive paper to remove surface defects and all indications of fretting. Inspect with a 10X magnifying glass to insure that absolutely no fretting indications remain. The abrasive paper must be mounted on a flat block so the polished surface will remain perfectly flat.

3. Without removing spindle from blade, shot peen both surfaces per AMS2430 to 98% minimum coverage, intensity .010A to .013A, with .019/.033 diameter steel shot. Mask with duct tape all areas and blade parts not to be peened. Overspray in the .625 dia bolt hole can be prevented by installing a .625 inch dia dowel or discarded bolt shank.

4. Polish peened surfaces using 220, 320 and 400 grit paper mounted on a flat block to keep surfaces perfectly flat. Do not remove all indications of shot peening, polish only until 95 to 98% of the surface appears polished and flat with only a few tiny pock marks from the shot peening still barely visible. Vibro-etch the letter "P" on the spindle as shown below. Caution: Remove all shot peen balls between the spindle and the boot.

5. Replace all six A106 Journals with new A106 Rev O or subsequent Journals obtained from the RHC factory after the date of this service bulletin. The new Rev O journals have yellow primed bores.

7. Reinstall main rotor blades per Section 9.112 of the R22 Maintenance Manual, except the bolt stretch shall be increased to .016/.017 inches. Be sure the journal and spindle surfaces are clean and dry before assembling. Also, exercise extreme caution to insure that the bolts are stretched to exactly .016/.017 inches using tool MT 122 per Section 9.112. Track and balance the rotor as required per Section 10.200.
