SERVICE BULLETIN #62

SUBJECT: Air Duct Chafing Oil Line

ROTORCRAFT AFFECTED: R22 Helicopter S/N 0002 thru 1392

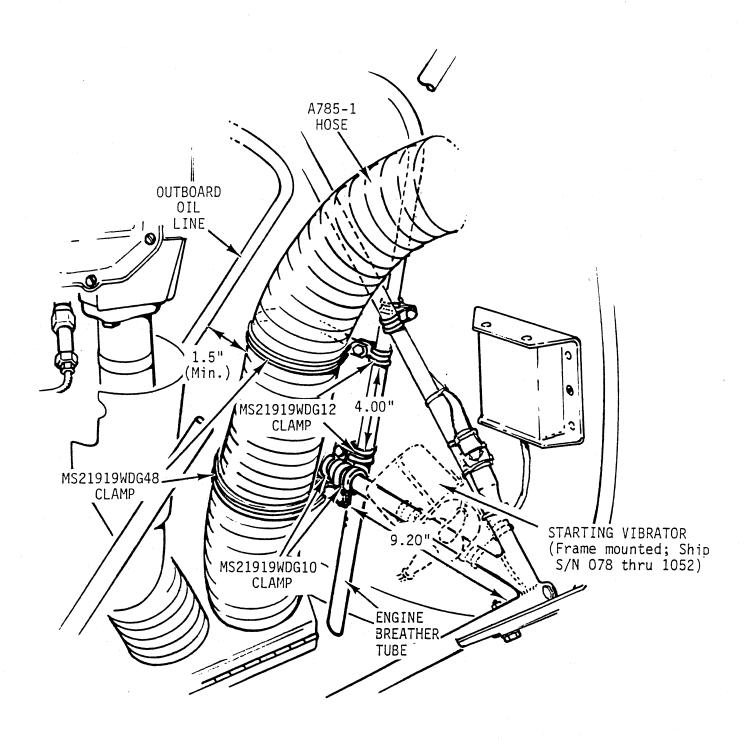
FIGURE 1

There have been two reports of the inlet air duct chafing the outboard oil cooler line causing an inflight loss of oil pressure. Continued operation of the engine without oil pressure will result in engine failure.

- 1. Remove A378-2 right hand skirt assembly.
- 2. Remove 2 ea. MS21919WDG-48 clamps from A785-1 hose assembly.
- 3. Remove clamps MS21919WDG-12 and MS21919WDG-10 from lower frame tubes.
- 4. Remove clamps MS21919WDG-12 and MS21919WDG-10 on lower engine breather tube A727-1 and frame.
- 5. Check and inspect outboard oil line and A785-1 hose for nicks, grooves, scratches, or abrasive wear due to rubbing of A785-1 carburetor air induction hose. Any damage greater than .005 inch deep is cause for rejection of the oil line and hose assembly.
- 6. Reinstall all hose clamps as shown in Figure 1. Maintain minimum of 1.5" between A723 outboard oil cooler line and A785-1 carburetor air induction hose.
- 7. Reinstall A378-2 right hand skirt assembly. Recheck gap between oil cooler line and A785-1 carburetor air induction hose. Be sure all clamps are tight and secure.
