R22

SERVICE BULLETIN SB-96

SUBJECT: Main Rotor Blade Erosion

ROTORCRAFT AFFECTED: R22 Helicopters S/N 0002 thru 4100.

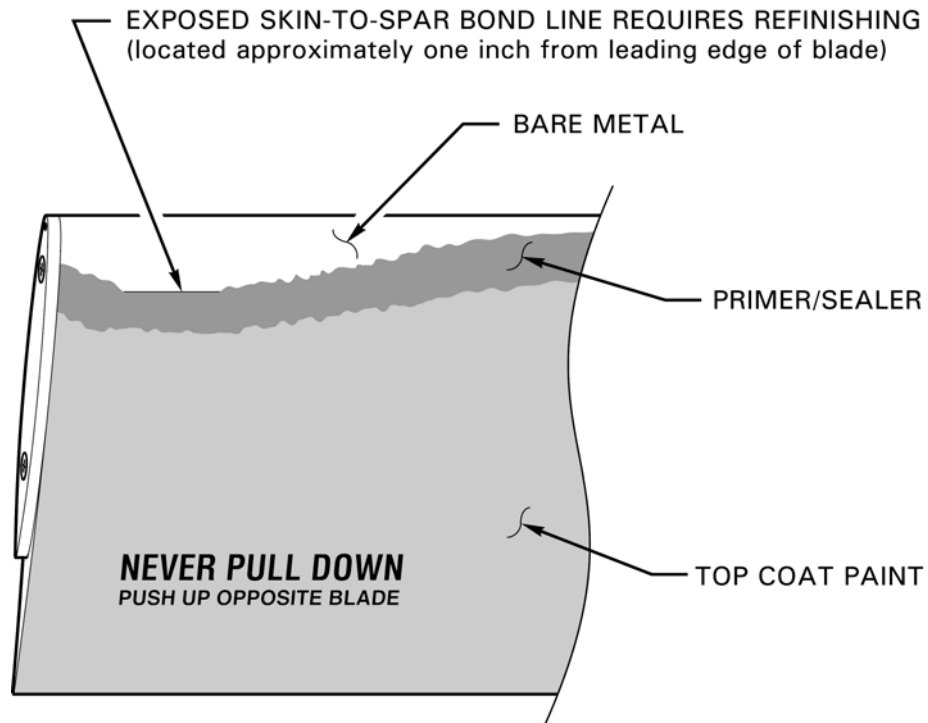
MAIN ROTOR BLADE LOWER SURFACE

BACKGROUND: RHC has received reports of main rotor blade skins beginning to debond (separate) at the skin-to-spar bond line on the lower surface near the blade tip. Debonding can occur when the bond line is exposed due to excessive erosion of the blade finish. This service bulletin requires one-time blade inspection and localized blade refinishing if erosion has occurred along the bond line.

1. Refer to Figure on page 2. Visually inspect lower surface of main rotor blades for excessive erosion. If any portion of bond line is exposed, proceed to step 2. If erosion has not exposed bond line, no further action is required.
2. Using 10x magnification, visually inspect leading edge of any exposed (bare metal) blade skin at the skin-to-spar bond line. Tap test all exposed skin-to-spar bonded areas with a 1965 or later U.S. quarter-dollar coin. If any indications of separation or any voids are detected, blade is unairworthy.
3. If no voids or indications of separation are found, refinish eroded portion of blade(s) per R22 Service Letter SL-56.
4. Notify RHC Technical Support of any unairworthy blades. Make appropriate maintenance record entries.
