R22

SERVICE BULLETIN SB-97

SUBJECT: Pedal Support Safety Tabs

ROTORCRAFT AFFECTED: R22 Helicopters S/N 0002 thru 3325 with more than 2200 hours total time in service.

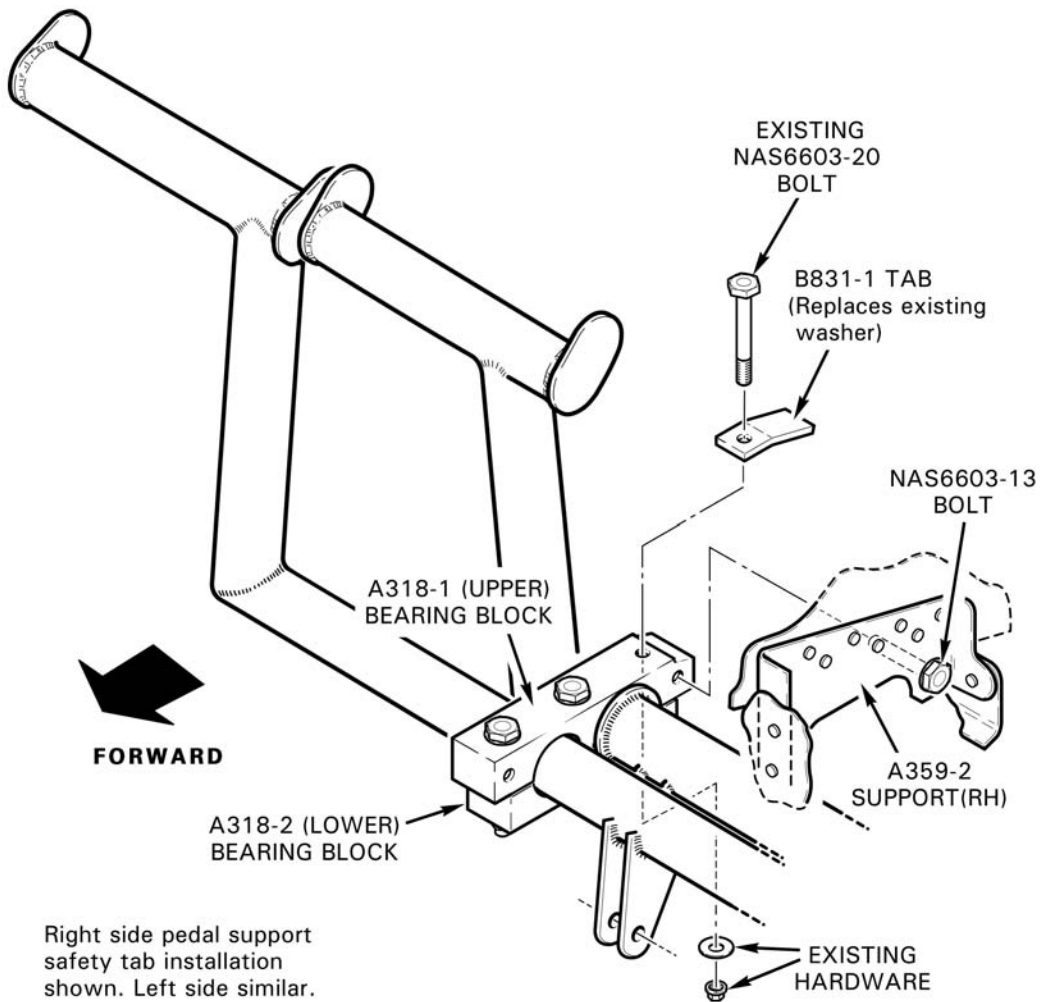
BACKGROUND: RHC has received reports of early-revision 0.040-inch thick A359-1 & -2 pedal bearing block supports cracking on aircraft with more than 7000 hours time in service. Later-revision supports are thicker. If helicopter has more than 2200 hours time in service and 0.040-inch thick supports are installed, this Service Bulletin requires installing safety tabs to prevent possible tail rotor control binding if a support fails.

1. Refer to figure on page 2. Open instrument console to access left A359-1 and right A359-2 supports. Visually inspect both supports and verify no cracks. Pay particular attention to area near NAS6603-13 bolts. Replace any cracked support before further flight.

5. Install a B831-1 tab under head of both NAS6603-20 bolts per figure on page 2. Torque both bolts at head to 55 in.-lb and torque stripe.

6. Reinstall covers between pedals and secure carpet with B270-7 contact adhesive (3M #74, or equivalent).
7. Make appropriate maintenance record entries.
8. At next 2200-hour overhaul, replace 0.040-inch thick A359-1 and/or -2 supports with thicker version.
