Robinson Helicopter Company

SERVICE LETTER #13

Subject: Loose horizontal firewall to steel tube frame attach bolts

Rotorcraft Affected: R22 Serial No. 0002 thru 0150, 0152-0182, 0184-0188
0190-0195, 0198

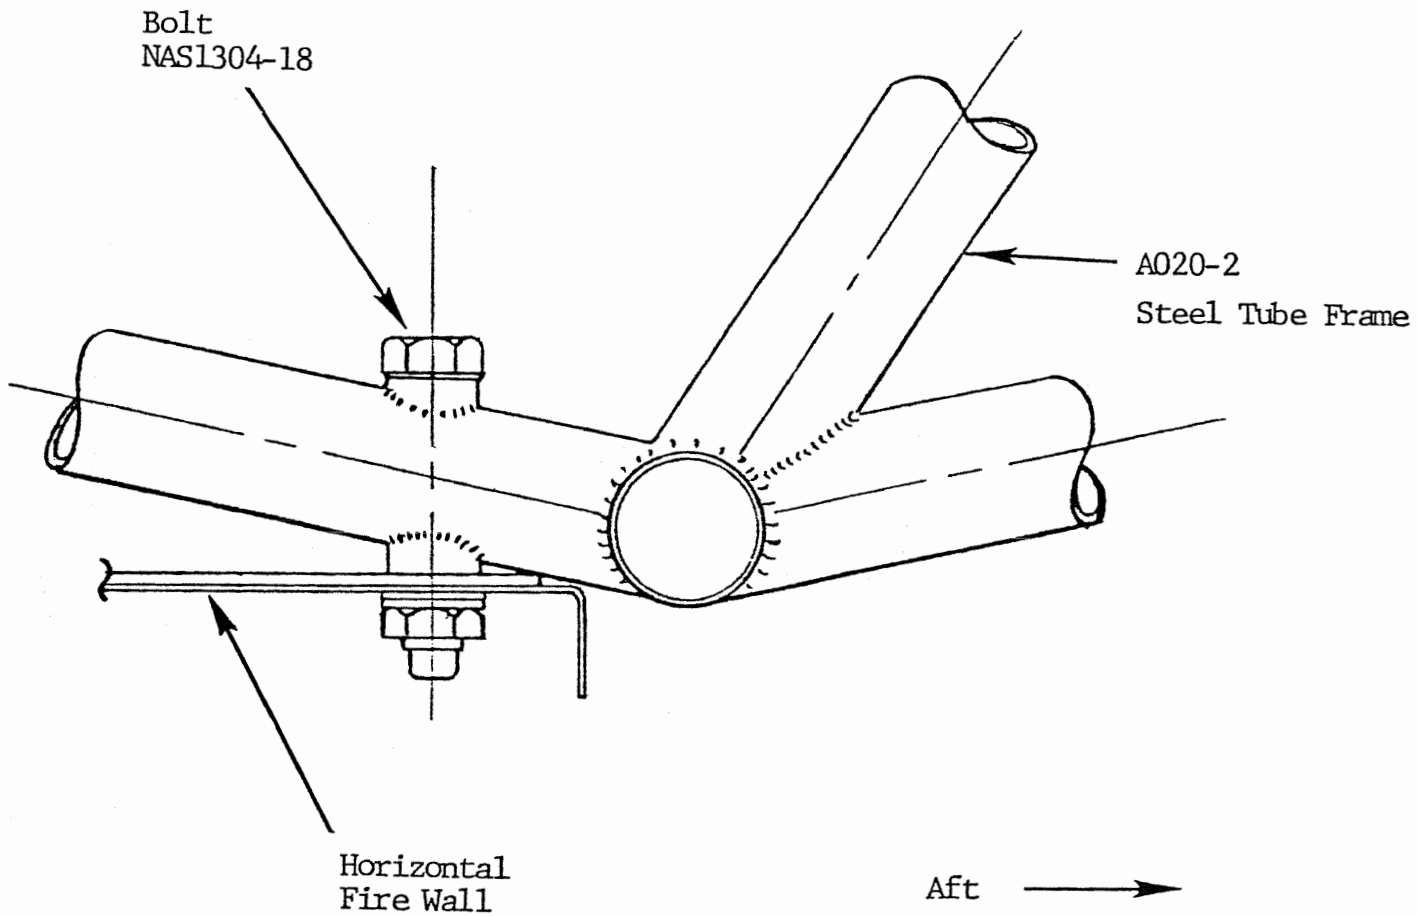
Fig #1

Background: After inspecting a number of helicopters, several were found to have loose NAS1304-18 attach bolts fastening the upper steel tube frame (lower horizontal member) to the aft horizontal firewall. (See fig. #1) To prevent improper loading at these areas, the NAS1304-18 bolts must be checked for proper torque and retorqued as necessary to provide proper clamping of these joints.

1. Using a suitable torque wrench, torque the bolts to 100 in/lbs plus nut drag.

Due to inaccessability of nut, it is permissible to hold the nut and torque the bolt.

2. Torque stripe the nut.

Note:
Torque nuts to 100 inch/pounds
plus nut drag
