Robinson Helicopter Company

Service Letter # 15

Subject: Visual inspection of main rotor blade root area

Rotor Blades Affected: Main rotor blade serial number 0100-0593
Part number A016-1, Revisions A through V

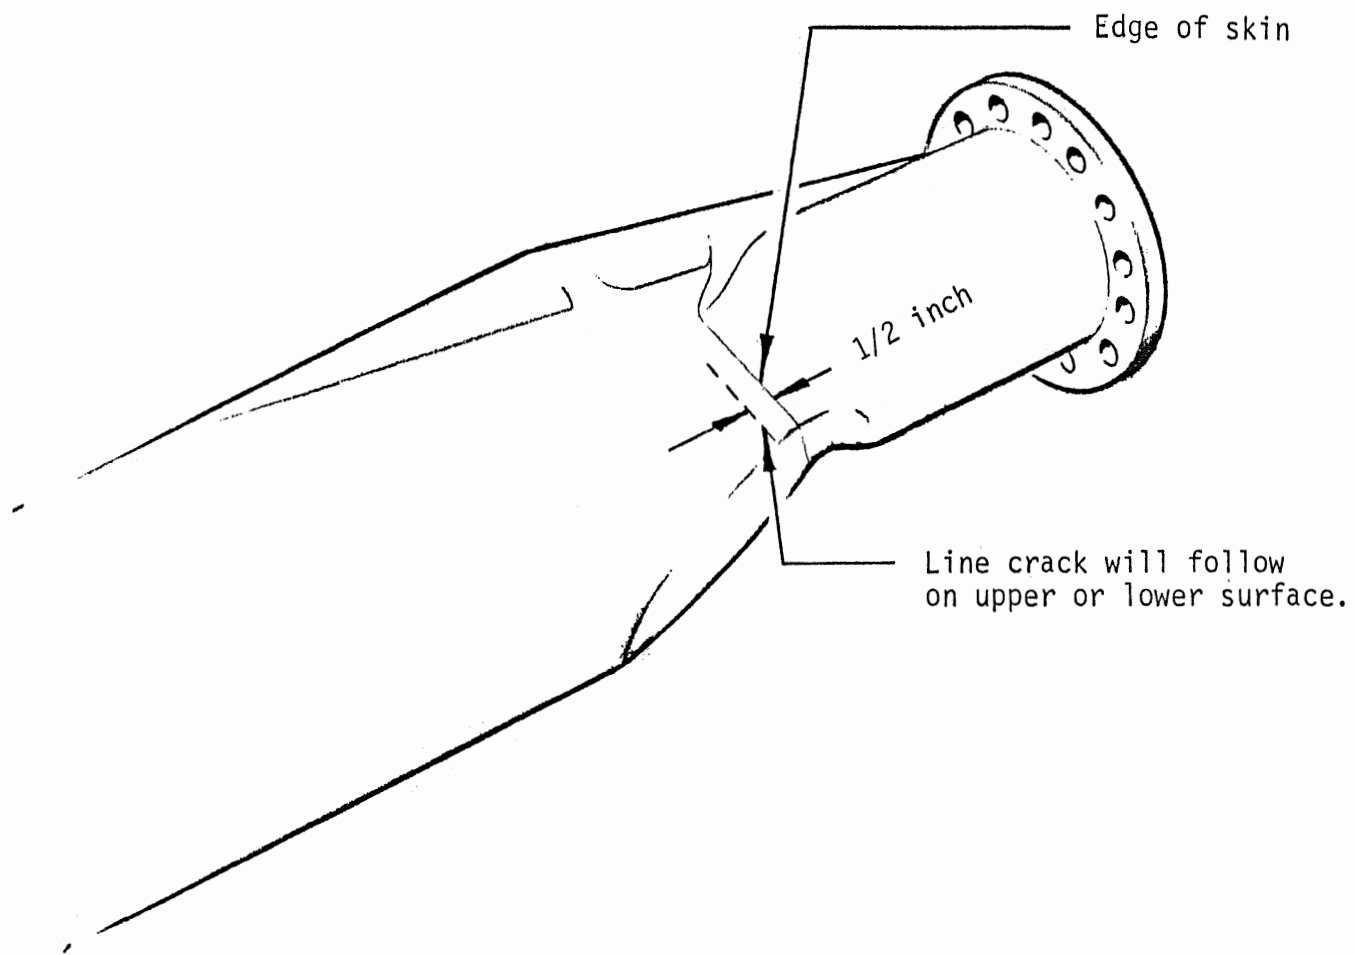
FIGURE # 1

Background: As described in AB-13, there is the remote possibility of a crack occurring in the root fitting of the main rotor blade. In addition to the service life reduction already in effect, it is recommended that the following precautionary inspection also be performed.

1. Visually inspect the upper and lower skins of the main rotor blades in the area shown in figure #1.
2. Inspect for signs of crack developing in the upper or lower skins at this location. Any evidence of cracking requires immediate removal of the main rotor blade from service.
