ROBINSON
HELICOPTER COMPANY

SERVICE LETTER #23A

Subject: Special Caution When Installing Vee Belts or Other Driveline Components

Rotorcraft Affected: All R22 Helicopters

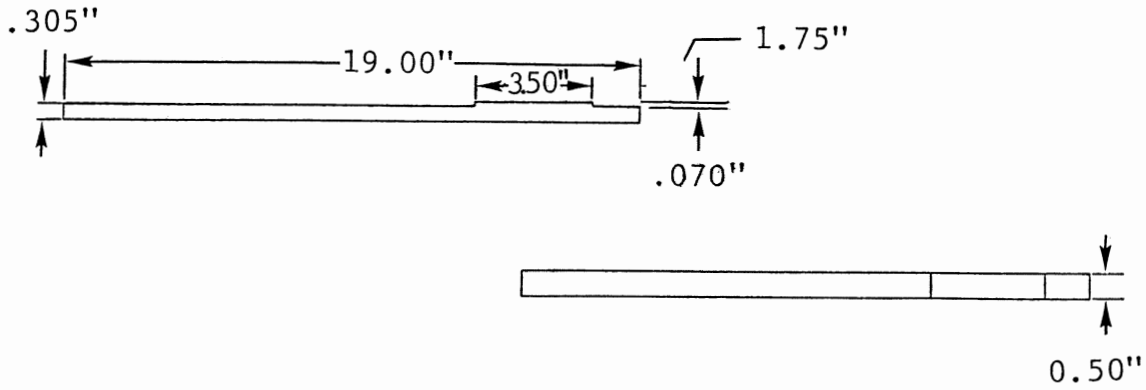
The MT331 alignment bar may be manufactured locally per Figure 1.

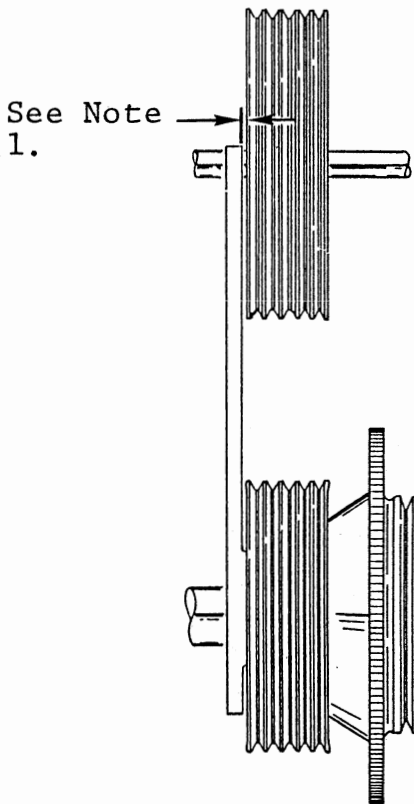
View from right side.

Note 1.

This gap will be .070" when sheaves are aligned and .000" when upper sheave is .070" aft of the lower sheave.

- a) The upper sheave must not be forward of lower sheave. It must be .000" to .070" aft of lower sheave.
- b) The difference between the left and right sheave alignment measurements must not be greater than .020". If measurements differ more than .020", adjust lateral clutch centering per Section 7.250 of the Maintenance Manual.

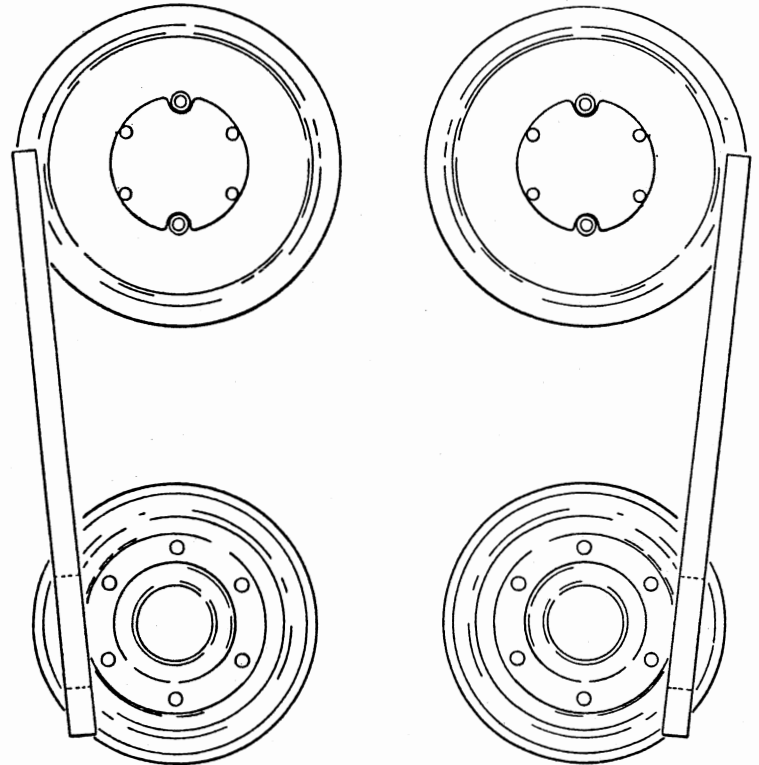
Sheave alignment bar position.

3. Engage clutch.
4. Using the MT331 Sheave Alignment Bar, check sheave alignment on left and right sides of upper and lower sheaves per Figure 2.

The upper clutch sheave must be aligned with the lower sheave within the following tolerances:
