SERVICE LETTER #25

Subject: Modification of A437 Jackshaft Brace Tab

Rotorcraft Affected: R22 Serial No. 0002 through 0435

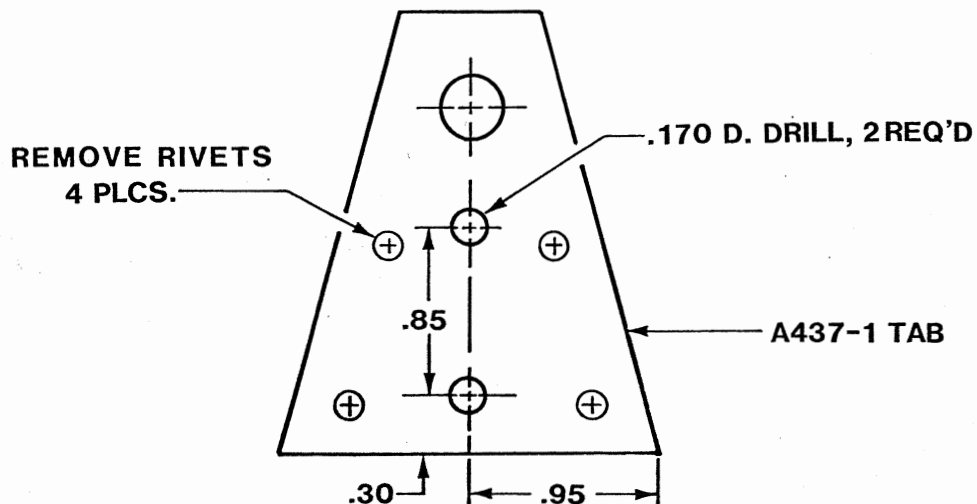
Background: Tab has been modified so it can be removed along with the jackshaft forward strut and rod end as a complete assy. This eliminates the need to remove the forward jackshaft strut rod end from the assembly when removing the Main Rotor Gearbox from the helicopter.

At Overhaul or sooner at owner's discretion
Modify the tab as follows:

1. Drill two .170 dia. holes per drawing below.
2. Install two AN525-832R6 screws, two AN960-8L washers and two NAS679A08 nuts.
3. Drill out the four MS20470AD4 rivets that attach the tab to the brace. Deburr holes and touch up primer.
