SERVICE LETTER #34

SUBJECT: Excessive Oil Leakage from Tail Rotor Gear Box  
Breather Tube.

ROTORCRAFT AFFECTED: All R22 Helicopters

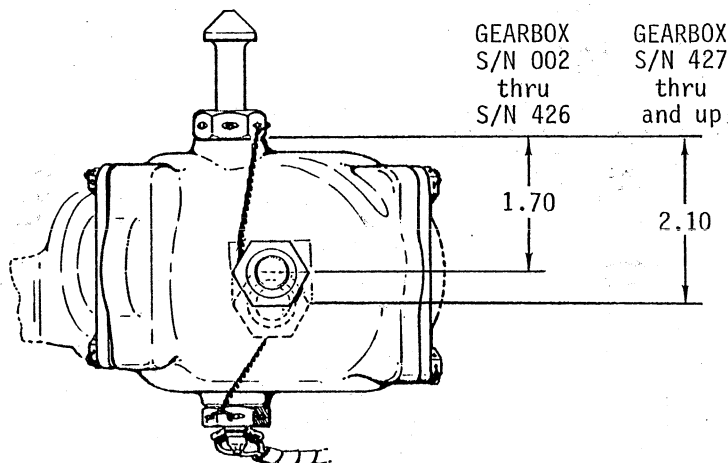
BACKGROUND: Overfilling has occurred on several tail rotor gearbox's which have the old style higher sight glass installed resulting in excessive oil being blown out of the Breather tube.

Before filling or adding oil to the Tail Rotor Gearbox first determine whether the Gearbox has the older or new style sight gage installed.

Gearbox S/N 002 through 426

Gearbox S/N 427 and on

Fill the gearbox only to the point where oil is just visible in the sight glass with the tail pulled down 1 to 1½ feet.

Fill Gearbox until the oil just reaches the center of the sight glass.
