SERVICE LETTER #35

SUBJECT: Alignment of Vee Belt Sheaves

ROTORCRAFT AFFECTED: All R22 Helicopters

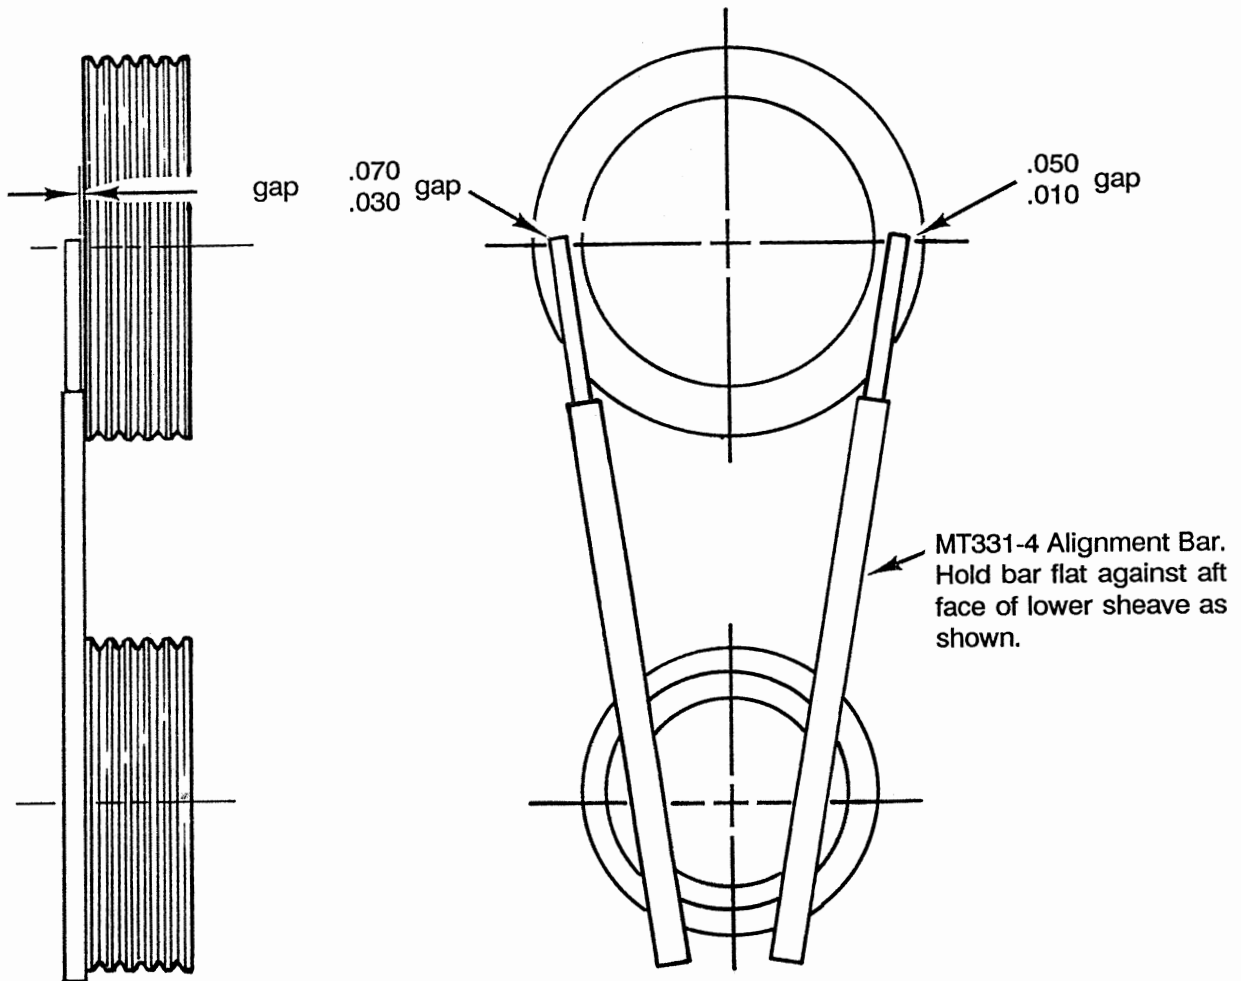
Figure 1
View Looking Forward

BACKGROUND: Tests conducted by the RHC factory indicate that most vee belt problems and failure of the fan shaft bearing or upper actuator bearing are caused by misalignment of the vee-belt sheaves. A new alignment procedure and tool MT331-4 is now available.

- a) Fully engage clutch actuator.
- b) Check sheave alignment on left and right sides per Figure 1 on reverse side.
- c) The clutch lateral centering strut may be adjusted to meet the requirements shown in Figure 1, but the following clearances must be maintained:
 - 1) Minimum .030 between clutch actuator motor and steel tube frame.
 - 2) Minimum .25 between V-belts and right side frame guard tube.

- a) Check engine ring gear to frame limits per Section 6.130 of the R22 Maintenance Manual.
- b) Fully engage clutch actuator.
- c) Check sheave alignment on left and right sides per Figure 1 on reverse side.
- d) If the measured gaps are not in tolerance, the upper sheave must be shimmed by adding or removing AN 960-516L washers at the forward flex plate, or by shimming the engine forward or aft per Section 6.130 of the R22 Maintenance Manual. Note: A maximum of one AN960-516L washer may be installed between the flex plate and either or both yokes. When a yoke is shimmed, both arms must have a washer.
- e) If the above shimming is not sufficient, a longer or shorter A907 yoke must be installed.
- f) Whenever the upper sheave is shimmed, the intermediate flex plate shims must be checked per Section 7.330 of the R22 Maintenance Manual.
