SERVICE LETTER #36

DATE: 5 October 1990
TO: All R22 Owners and Service Centers
SUBJECT: Alignment of Fan Shaft Bearing Housing
ROTORCRAFT AFFECTED: All R22 Helicopters

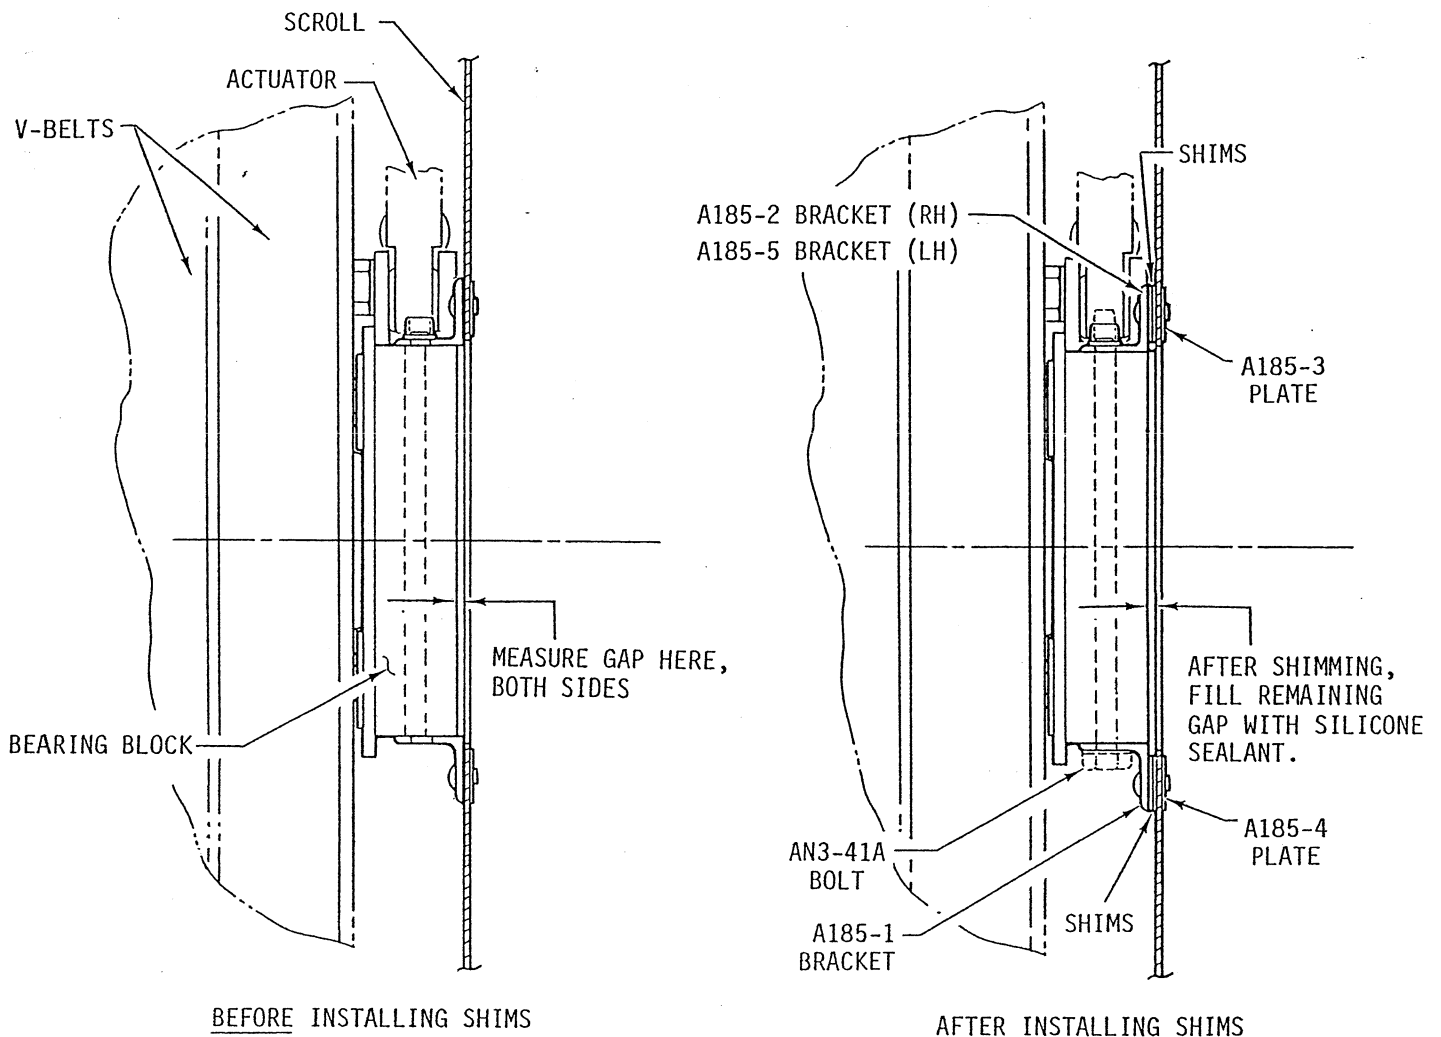
BACKGROUND: Premature failure of fan shaft bearing or failure of bearing housing mounting brackets on fan scroll can result if bearing housing is misaligned.

1. With scroll still installed, remove two AN3-41A bolts from the fan shaft bearing housing. (Caution: Be sure clutch is disengaged.)
2. Tap scroll in several places near bearing to allow scroll to move to its unloaded, free standing position.
3. Measure and record the gap, if any, between scroll and fan shaft bearing, see figure. Gap is accessible from bottom and should be measured at right and left side of bearing. Also, check for cracks or loose rivets.

If gaps are .05 inch or more, shimming is required between scroll and A185 brackets as follows:

- a. Remove centrifugal blower and scroll per R22 Maintenance Manual, Section 6.210.
- b. Drill out rivets which mount A185-1, -2 and -5 brackets to scroll in those areas where shimming is required.
- c. To fabricate shims, cut and drill 2024-T3 aluminum sheet, thickness .032 inch, to match A185-3 and -4 plates. Additional A185-3 and -4 plates may be obtained from RHC to use as shims if desired. Install shims to fill gaps between A185 brackets and scroll.
- d. If gap is larger on one side than the other, the larger gap may have up to two more shims than the opposite side. A maximum of five shims may be added at any corner.

- e. Reinstall A185-3 and -4 plates inside scroll using MS20470AD5 (5/32 diameter) rivets to rivet the A185 plates, scroll, shims and A185 brackets together.
- f. Reinstall centrifugal blower and scroll per R22 Maintenance Manual Section 6.220, but before torquing blower nut, check for clearance between the blower and scroll by holding blower forward and rotating it on fan shaft by hand. If any indication of contact between scroll and blower occurs, remove scroll and adjust shims as required to provide clearance.
- g. Reinstall blower nut and roll pin per R22 Maintenance Manual Section 6.220. Double check blower clearance by cranking engine with lower spark plugs removed.
- i. Using RHC B270-4 sealant or standard silicone type sealant, fill gaps between fan shaft bearing block and scroll, to prevent excessive cooling air loss.
