ROBINSON HELICOPTER COMPANY

R44

SERVICE BULLETIN SB-17

SUBJECT: Pilot's Grip Assembly

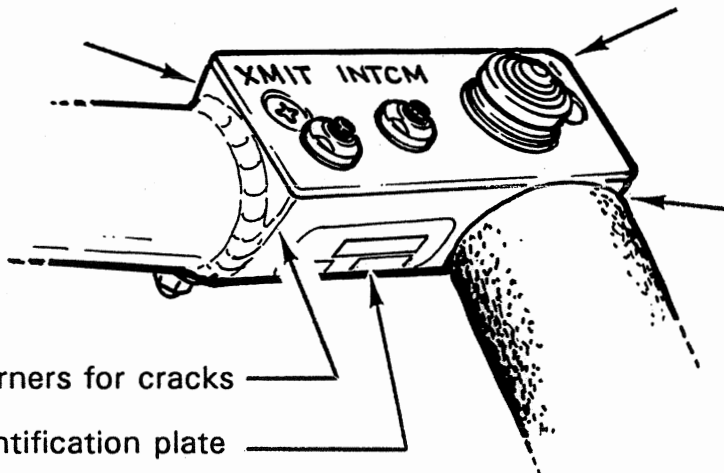
BACKGROUND: RHC has received one report of an early-revision pilot's grip assembly which developed a crack.

PART A: Visually inspect areas noted in figure for cracks (may be performed by pilot in command). If any cracks are noted, perform Part B.

Inspect all four corners for cracks

Grip assembly identification plate

PART B: Install replacement grip included in RHC KI-112 Kit in accordance with kit instructions.
