R44

SERVICE BULLETIN SB-23

SUBJECT: Replacement of C018-1 Clutch Assembly

ROTORCRAFT AFFECTED: R44 Helicopters S/N 0001 through 0322 excluding S/N 0182, 0224, 0228, 0253, 0301, 0306, 0307, 0311, 0312, 0314, and 0319.

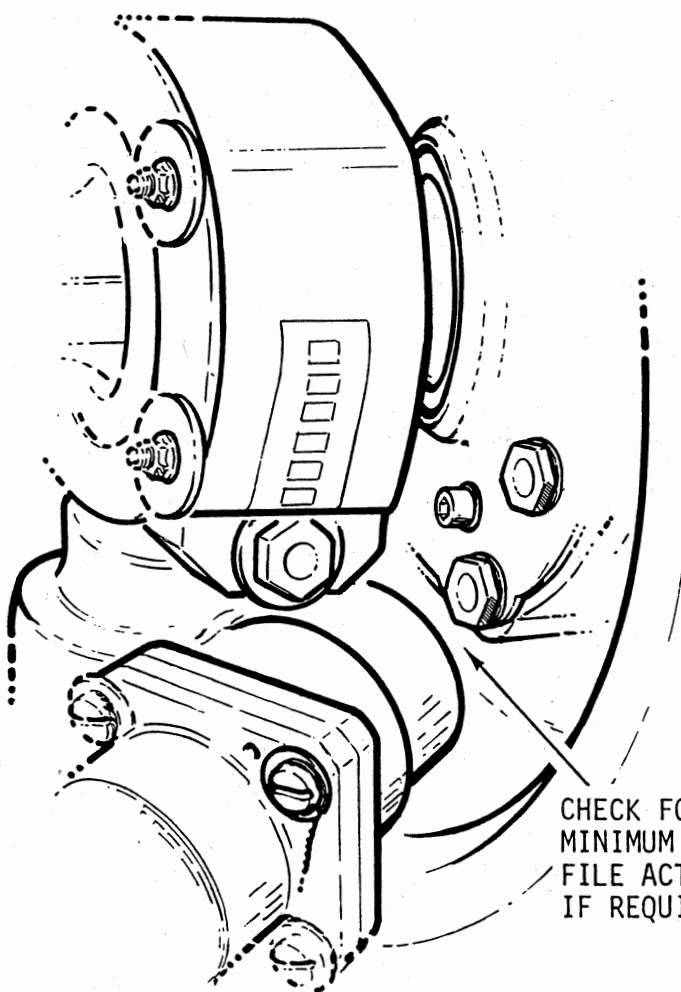
CHECK FOR 0.06 INCH  
MINIMUM CLEARANCE.  
FILE ACTUATOR HOUSING  
IF REQUIRED.

8. Rotate upper sheave to obtain minimum clearance between sheave bolts and actuator gear housing per figure on page 2. Engage clutch switch to fully tension V-belts. Check for 0.06 inch minimum clearance between bolts and housing. Housing may be filed to provide clearance if required.
