R44

SERVICE BULLETIN SB-27B

SUBJECT: Main Rotor Blade Inspection

ROTORCRAFT AFFECTED: R44 Helicopters S/N 0002 thru 0486 equipped with C016-1 Main Rotor Blades.

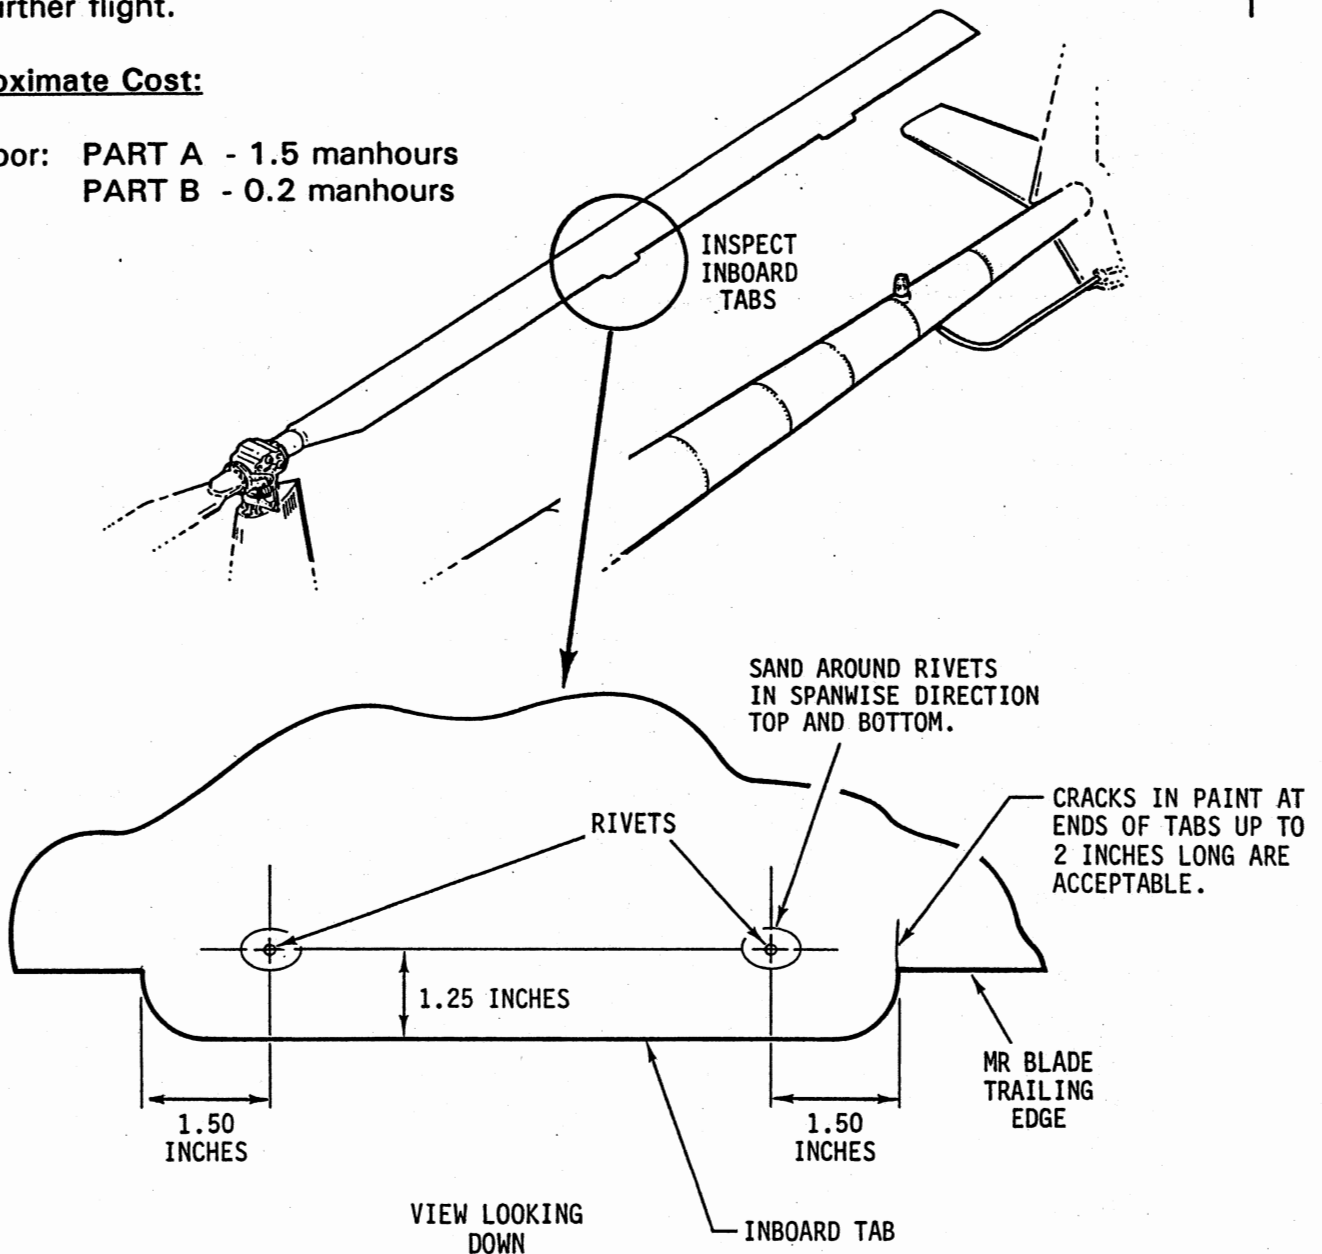
BACKGROUND: RHC has received a report of a cracked main rotor blade skin. The crack was through a trim tab rivet hole and ran forward to the blade spar. The pilot heard a loud noise, felt a severe vibration, and landed immediately. There was no helicopter damage or injury to the passengers, but continued flight could have been catastrophic.

Visually inspect blade surfaces around both rivets at inboard trim tab on top and bottom of blade (4 places per blade). Using 5 power or greater magnifying glass, carefully check area around each rivet. Cracks will start from edge of rivet hole and progress radially, probably in chordwise direction. A crack may be very thin (hairline or thinner) and appear only as a small scratch. Any possible crack indication, no matter how small, requires additional inspection by a qualified mechanic. Any blade with a positive crack indication must be replaced before further flight.

1. Refer to figure on page 2. Remove all paint around both rivets at inboard trim tab on top and bottom of blade (4 places per blade). Use 180 grit or finer abrasive paper, followed by 600 grit or finer abrasive paper. Sand only in spanwise direction. (Pulling a strip of abrasive paper across rivet area while applying pressure on paper with your thumb is an effective method.) Do not use chemical paint strippers.

2. Dye penetrant inspect blade surfaces around rivet holes at all four locations in accordance with dye penetrant manufacturer's instructions. Scrap and replace blades with any indication of a crack at a rivet hole. (Chordwise cracks in paint up to 2 inches long are acceptable at either end of trim tab.)

3. Clean sanded area with 111-Trichloroethane or MEK. Apply clear lacquer (or clear fingernail polish) to seal surface.
4. When tracking blades, avoid bending inboard tab. Make adjustments at outboard tab.
