R44

SERVICE BULLETIN SB-34

SUBJECT: Tail Rotor Gearbox Output Shaft Bearing Preload

ROTORCRAFT AFFECTED: R44 Helicopters S/N 0002 thru 0616 except 0440, 0542, 0583, 0592, 0602, 0611, and 0614.

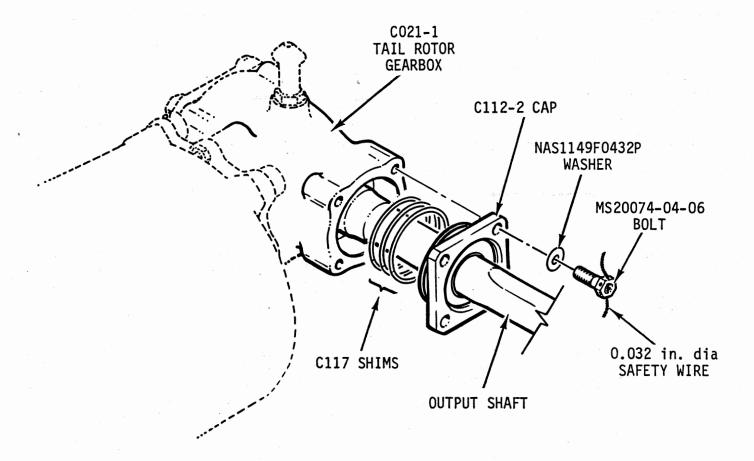
BACKGROUND: Two R44 C021-1 tail rotor gearboxes have been found with spalling on the output shaft bearings. The gearboxes were returned to RHC after repeated tail rotor chip lights. To prevent further occurrences, bearing preload must be reduced on C021-1 Rev F and prior gearboxes by reducing the C117 shim stack 0.002 inches.

- 1. Order KI-146 kit.
- Refer to figure on page 2. Cut safety wire and remove four MS20074-04-06 bolts securing C112-2 cap. Place a container under gearbox. Slide C112-2 cap away from gearbox and allow oil to drain into container (tail may be pulled down to promote oil drainage). Wipe cap and gearbox mating surfaces clean (cap o-ring and seal will be reused).
- 3. Slide C117 shims out of gearbox housing. Measure thickness of each shim.

- 4. Select one C117 shim from step 3 that is 0.002 inch thicker than one shim from KI-146 kit.
- 5. Replace shim selected in step 4 with shim from KI-146 kit. (Installed shim must be cut for removal.) Replacement shim location in shim stack is not critical.
- 6. Position C117 shim stack against bearing and slide C112-2 cap into position.
- 7. Install MS20074-04-06 retaining bolts, torque to 60 inch-pounds, and safety wire.
- 8. Fill gearbox with new A257-2 gear oil. Torque filler vent plug to 100 inch-pounds and safety wire.

- 9. Mark gearbox with a 0.25 inch diameter white painted dot between sight gage and data plate.
- 10. Make appropriate maintenance record entry.
