SERVICE BULLETIN SB-37

SUBJECT: Aft C121-25 Push-Pull Tube Contact with Mast Fairing Rib

ROTORCRAFT AFFECTED: R44 Helicopters S/N 0653, 0655, 0661, 0664, 0665, 0667 thru 0678, 0680 thru 0683, 0686 thru 0695, 0698, and 0709.

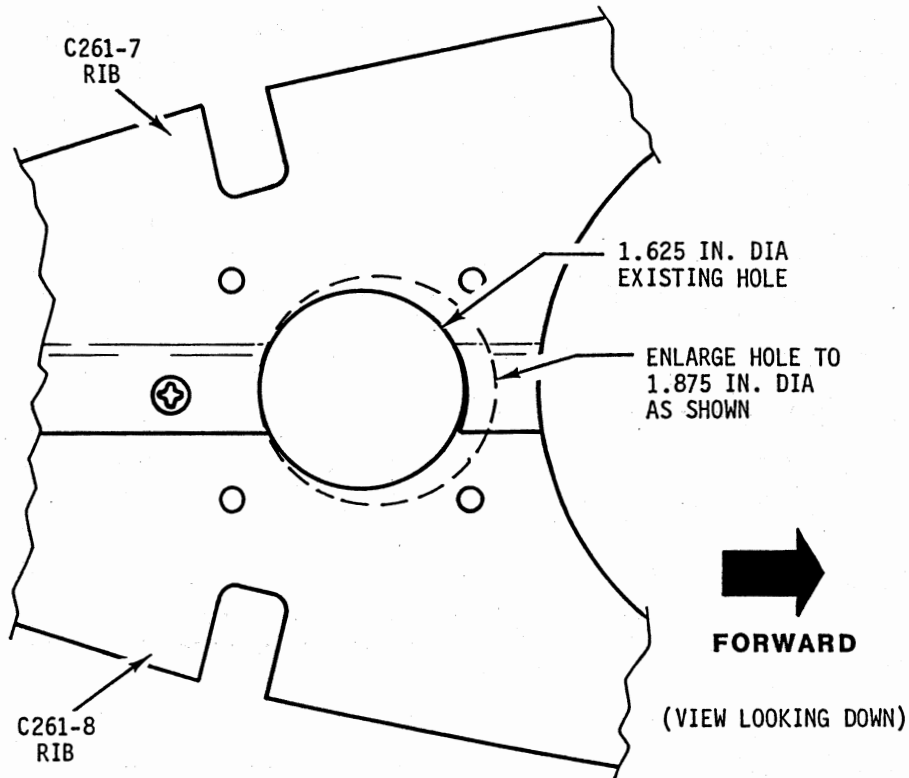
BACKGROUND: RHC has received reports of the aft C121-25 push-pull tube rubbing the mast fairing middle rib. Enlarging the rib hole will provide necessary clearance.

5. Securely assemble both halves of middle rib without aft grommet.
6. With a 1.875 inch diameter circular template (a socket with an outside diameter of 1.875 inch will work), layout and mark the boundary of the hole enlargement as shown in figure on page 2.

7. Using a rotary file, nibbler, or similar tool, enlarge hole from 1.625 to 1.875 inch diameter along boundary marked in preceding step.
8. Disassemble rib. Deburr and polish enlarged hole edge and prime with zinc-chromate or epoxy primer.
