SERVICE BULLETIN SB-40

SUBJECT: Emergency Pop-Out Float Pressure Cylinder Valve

ROTORCRAFT AFFECTED: R44 Helicopters with emergency pop-out floats thru S/N 0848 except S/N 0748, 0811, 0816, 0828, 0829, and 0831.

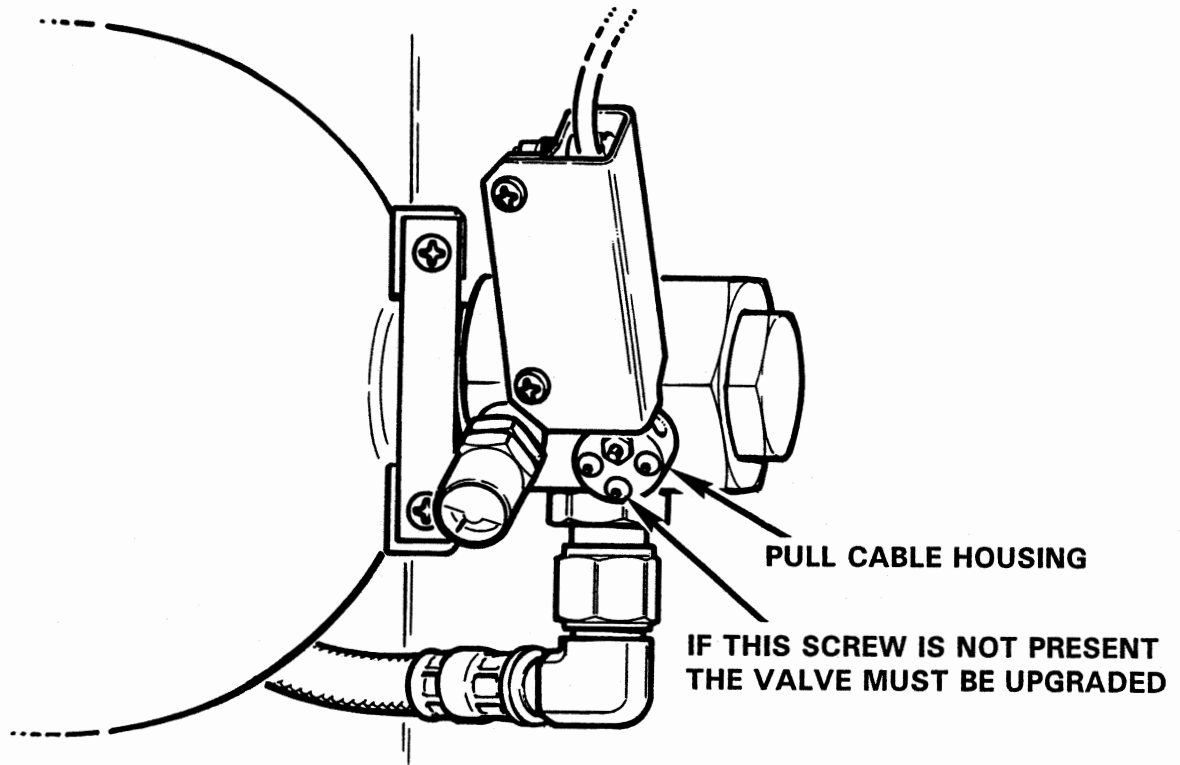
NOTE: Upgraded valves can be identified by the number of screws retaining the pull cable housing. If there are two hold-down screws, the valve requires upgrading. Three screws indicate upgraded valve. See figure on page 2.

1. Order replacement D679-1 cylinder assembly and KI-151 cylinder pressure bleed-off kit from RHC Customer Service.
2. Depressurize cylinder using bleed fitting and instructions supplied in KI-151 kit.
3. Remove pressure cylinder per R44 MM section 5.660.
4. Install new D679-1 pressure cylinder per R44 MM section 5.670.
5. Ship empty cylinder and bleed fitting to RHC.
