R44

SERVICE BULLETIN SB-41A

SUBJECT: Tail Rotor Rigging

ROTORCRAFT AFFECTED: R44 Helicopters S/N 0001 thru 1225 except 1183, 1196, 1197, 1198, 1203, 1204, 1209 thru 1212, and 1219 thru 1224.

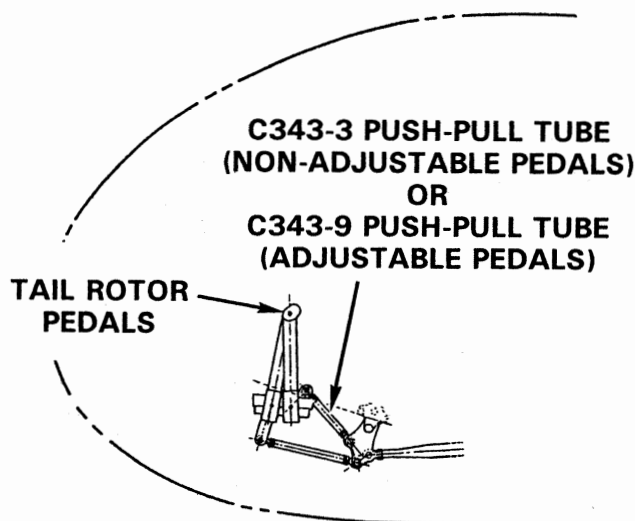
BACKGROUND: Inadvertent abrupt application of full left pedal by the student during a simulated power failure could result in excessive flapping of the tail rotor and possible tail rotor blade contact with the tailcone. To reduce the possibility of that occurring, Safety Notice SN-27 Surprise Power Chops Can Be Deadly was reissued as a Safety Alert. In addition, Service Bulletin 41 was issued requiring reduction of the left pedal stop blade angle by five degrees (to 16.5°~17.0°) and installation of a harder teeter bumper. Revision A is being issued to allow an additional two degrees tail rotor pitch at the left pedal stop for increased control margin in hover.

- c. Refer to figure below. Adjust C343-3 or C343-9 push-pull tube assembly per R44 MM section 10.002. Shortening C343-3 or -9 push-pull tube assembly will increase blade angles at left pedal stop. One turn of rod end increases blade angle approximately one degree for non-adjustable pedals or 1.5 degrees for adjustable pedals.

- d. After final adjustment to 18.5°~19.0° blade angle at left pedal stop, torque nut and palnut at push-pull tube rod end per R44 MM section 1.320, and torque stripe.
