R44

SERVICE BULLETIN SB-51

DATE: 24 November 2003

SUBJECT: NAS6605-31 Bolts

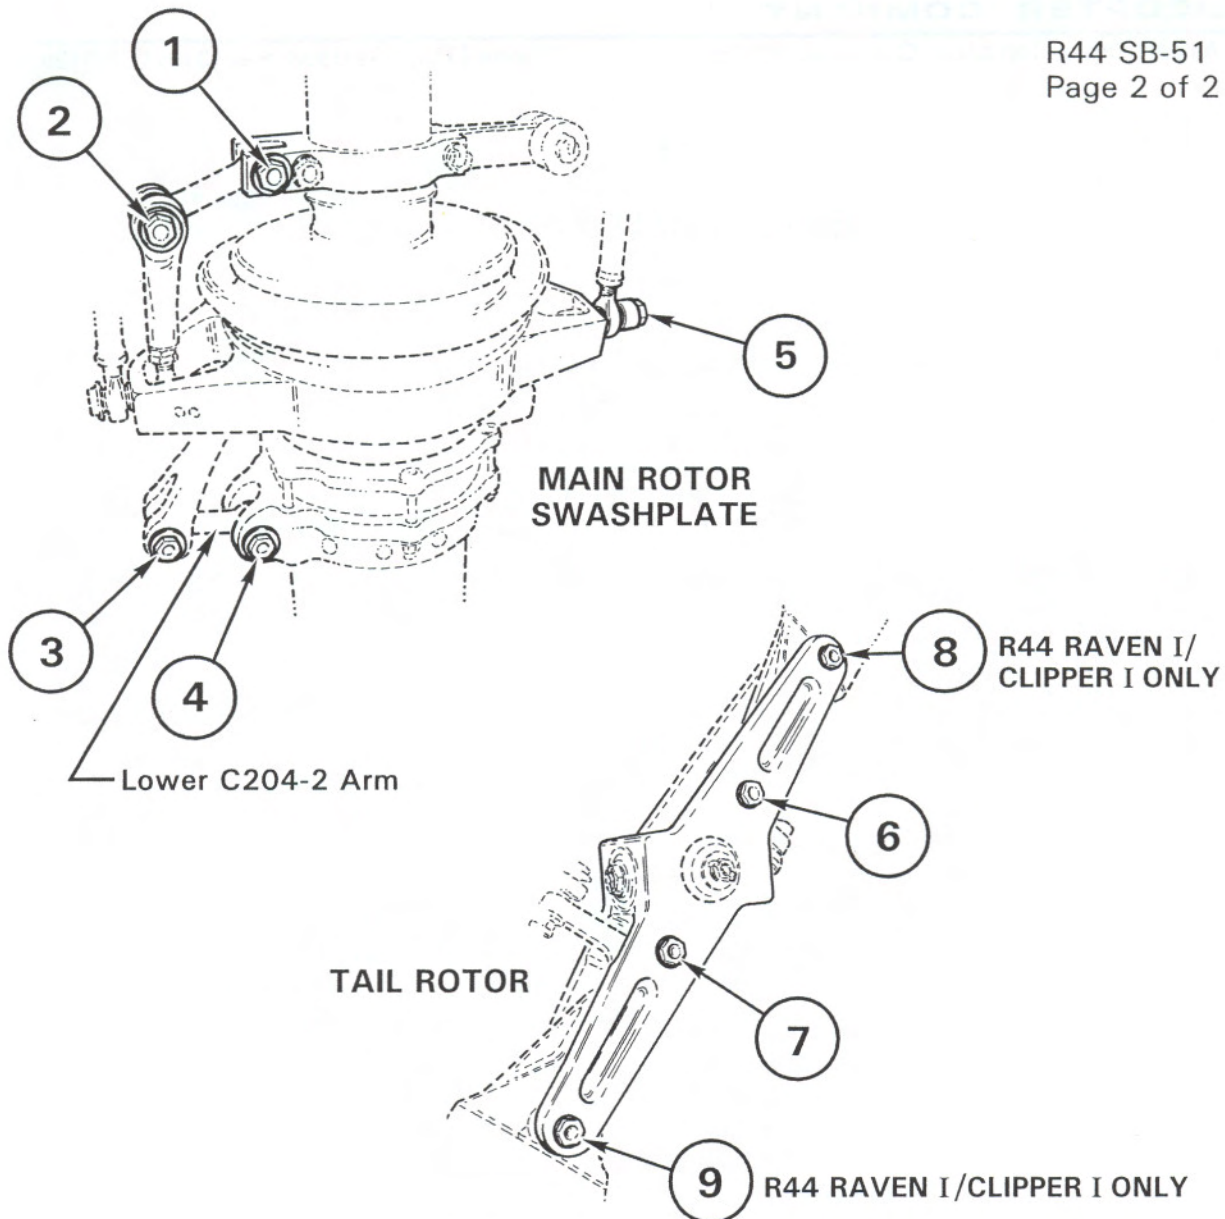
SUSPECT NAS6605-31 BOLTS

BACKGROUND: RHC has received one report of a failed NAS6605-31 bolt and has determined that the failure was due to hydrogen embrittlement. NAS6605-31 bolts are used 9 places on the R44 and 7 places on the R44 II as shown on the following page. Hydrogen embrittlement may occur due to improper process control during the cadmium plating process, making an entire manufacturing lot of bolts suspect.

9 places on R44
7 places on R44 II

Visually inspect all suspect NAS6605-31 bolts and verify no fretting residue under bolt head (residue would indicate a loose, potentially cracked bolt). Also apply approximately 10-15 ft-lb (13-20 N·m) torque to each bolt head and verify no rotation. It is not necessary to use a torque wrench; pilot or mechanic judgement using an ordinary wrench is adequate. Vary cyclic and collective position to provide access to bolts at lower C204-2 arm.

Order replacement NAS6605-31 bolts from RHC and replace all suspect bolts. Torque all fasteners per R44 Maintenance Manual. Destroy or return to RHC all removed bolts. Note that all suspect bolts will have vendor identification marking 01DO opposite the NAS6605-31 part number on the bolt head, but not all NAS6605-31 bolts with this marking are suspect. Replacement bolts will have an alternate vendor identification marking.
