R44

SERVICE BULLETIN SB-61

SUBJECT: Main Rotor Blade Erosion

ROTORCRAFT AFFECTED: R44 Helicopters S/N 0001 thru 1670. R44 II Helicopters S/N 10001 thru 11570.

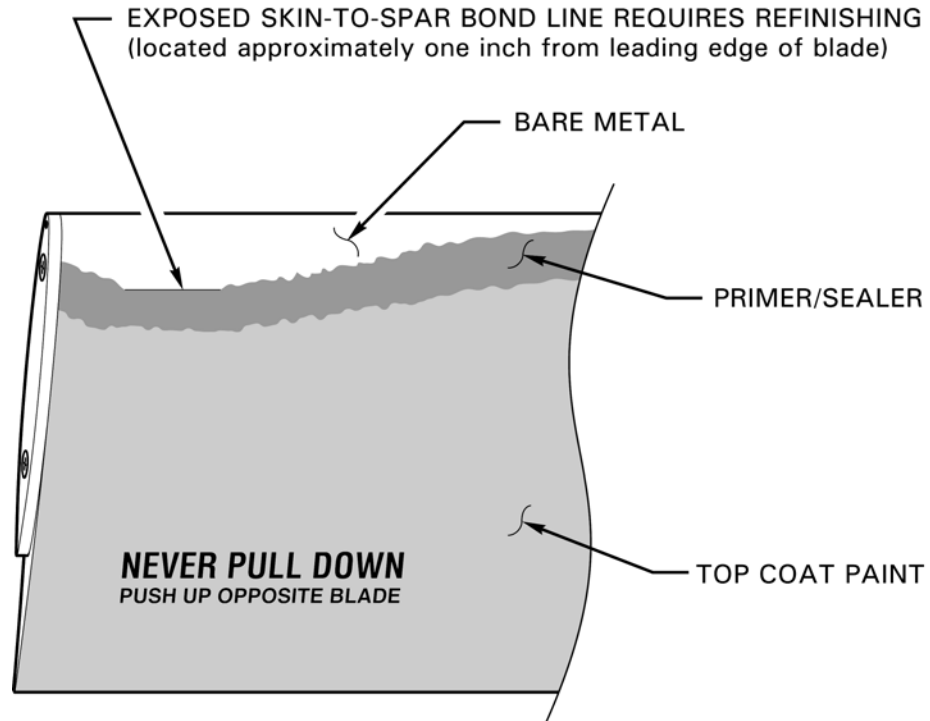
MAIN ROTOR BLADE LOWER SURFACE

BACKGROUND: RHC has received reports of main rotor blade skins beginning to debond (separate) at the skin-to-spar bond line on the lower surface near the blade tip. Debonding can occur when the bond line is exposed due to excessive erosion of the blade finish. This service bulletin requires one-time blade inspection and localized blade refinishing if erosion has occurred along the bond line.

1. Refer to Figure on page 2. Visually inspect lower surface of main rotor blades for excessive erosion. If any portion of bond line is exposed, proceed to step 2. If erosion has not exposed bond line, no further action is required.
2. Using 10x magnification, visually inspect leading edge of any exposed (bare metal) blade skin at the skin-to-spar bond line. Tap test all exposed skin-to-spar bonded areas with a 1965 or later U.S. quarter-dollar coin. If any indications of separation or any voids are detected, blade is unairworthy.
3. If no voids or indications of separation are found, refinish eroded portion of blade(s) per R44 Service Letter SL-32.
4. Notify RHC Technical Support of any unairworthy blades. Make appropriate maintenance record entries.
