R44

SERVICE BULLETIN SB-62

SUBJECT: R44 II Throttle Linkage

ROTORCRAFT AFFECTED: R44 II Helicopters S/N 10001 thru 12029 except S/N 11792, 11951, 11996, 11999, 12007, 12008, 12018, 12023, 12025, 12027, and 12028.

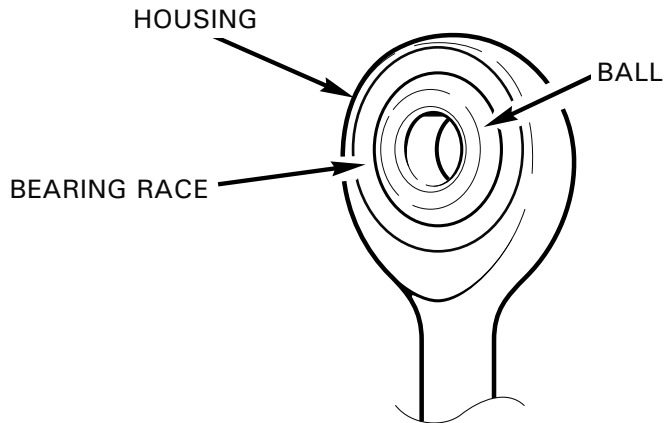
DETAIL OF LINK OR ROD END

BACKGROUND: A B564-2 throttle link failed due to the bearing race separating from the housing. Installing large-diameter safety washers will prevent loss of throttle control if a bearing fails.

- Verify no looseness between bearing race and housing.
- Verify no excessive looseness between ball and bearing race.

1. Refer to figure on page 2. Inspect spherical bearings at both ends of B564-2 link and at A933-3 rod end. Verify no looseness between bearing race and housing and no excessive looseness (maximum 0.020 inch axial and 0.010 inch radial play) between ball and bearing race. Replace link or rod end if required.
2. Replace NAS1149F0332P washer with A141-17 washer at both ends of B564-2 link and at A933-3 rod end as shown in figure. Torque nuts to 50 in.-lb, palnuts to 10 in.-lb, and torque stripe.
3. Verify throttle correlation rigging per R44 Maintenance Manual Section 10.150, Step 3.
4. Make appropriate maintenance record entries.
