R44

SERVICE BULLETIN SB-63

SUBJECT: Pedal Support Safety Tabs

ROTORCRAFT AFFECTED: R44 Helicopters S/N 0001 thru 1200 with more than 2200 hours total time in service.

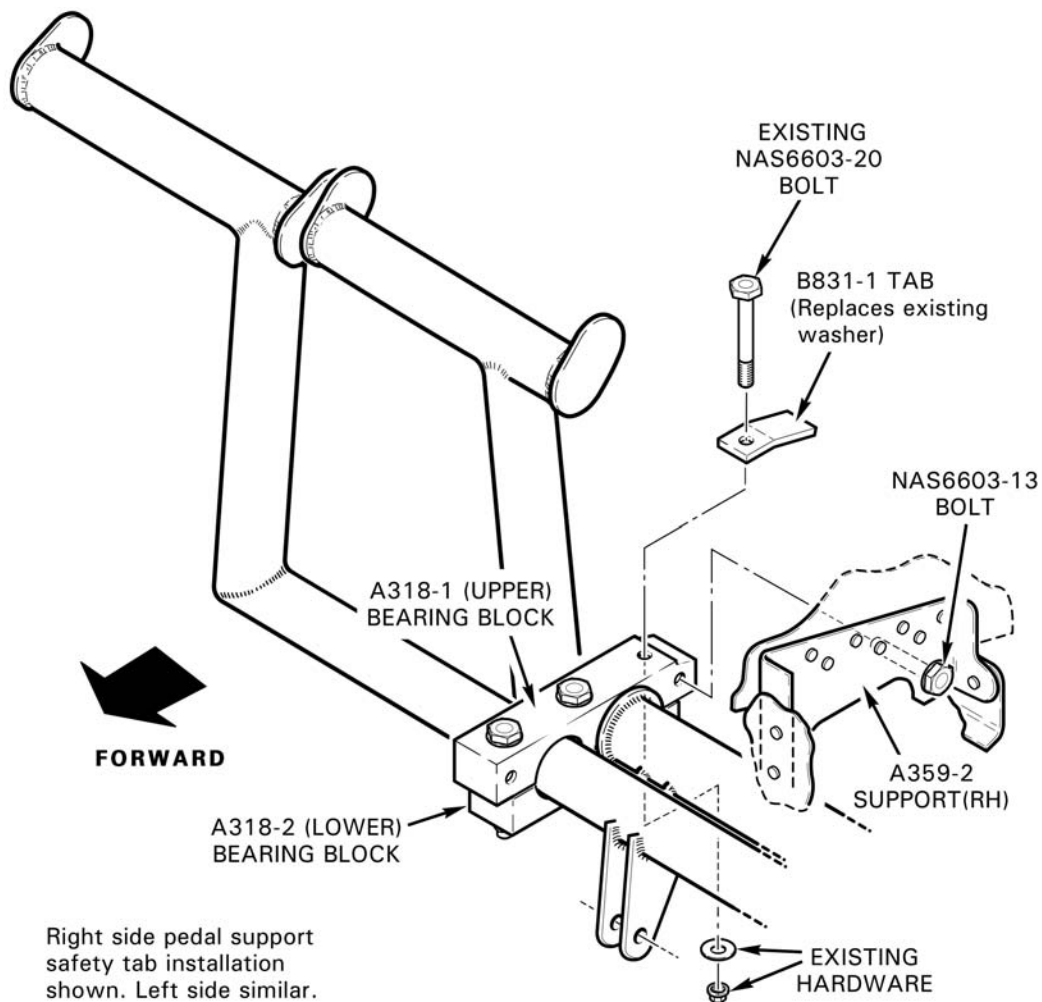
BACKGROUND: RHC has received reports of early-revision 0.040-inch thick A359-1 & -2 pedal bearing block supports cracking on aircraft with more than 7000 hours time in service. Later-revision supports are thicker. If helicopter has more than 2200 hours time in service and 0.040-inch thick supports are installed, this Service Bulletin requires installing safety tabs to prevent possible tail rotor control binding if a support fails.

1. Refer to figure on page 2. Open instrument console to access left A359-1 and right A359-2 supports. Visually inspect both supports and verify no cracks. Pay particular attention to area near NAS6603-13 bolts. Replace any cracked support before further flight.

4. Dampen carpet adhesive between left-seat and right-seat pedals with Dupont Prep-Sol (or equivalent) to facilitate removal. Gently peel back carpeting and remove covers between pedals. Remove aft-vertical NAS6603-20 bolt and corresponding hardware from left and right bearing blocks and discard one accompanying washer per side.

5. Install a B831-1 tab under head of both NAS6603-20 bolts per figure on page 2. Torque both bolts at head to 55 in.-lb and torque stripe.

6. Reinstall covers between pedals and secure carpet with B270-7 contact adhesive (3M #74, or equivalent).
7. Make appropriate maintenance record entries.
8. At next 2200-hour overhaul, replace 0.040-inch thick A359-1 and/or -2 supports with thicker version.
