R44

SERVICE BULLETIN SB-67

SUBJECT: R44 II Fuel Hose Supports

ROTORCRAFT AFFECTED: R44 II Helicopters S/N 10001 thru 12566.

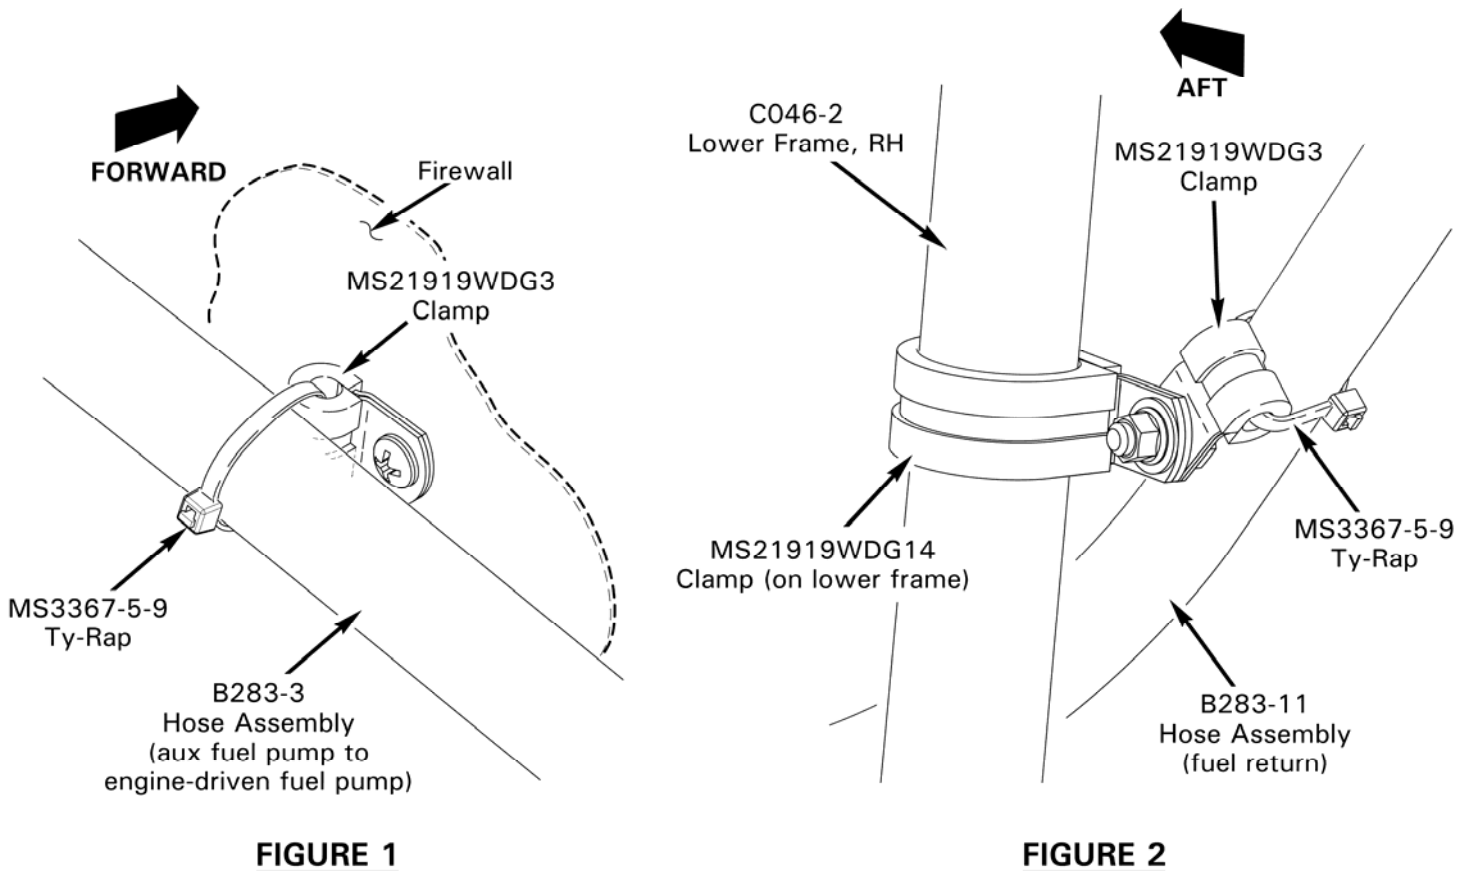
BACKGROUND: In an accident, the engine may shift relative to the airframe structure and cause fuel hose damage. This service bulletin requires replacing support clamps with ty-raps on two fuel hoses. Under high load, the ty-raps will break to provide fuel hose slack, reducing the likelihood of a post-accident fuel leak.

4. Refer to Figure 1. Attach MS21919WDG3 clamp to firewall using retained hardware, with fastener head toward hose as shown.
5. Insert MS3367-5-9 ty-rap through installed clamp and around B283-3 hose assembly. Cinch ty-rap until snug without overtightening and trim ty-rap tip flush with head.

7. Refer to Figure 2. Attach MS21919WDG3 clamp to MS21919WDG14 clamp using retained hardware, with fastener head toward hose as shown. Torque nut to 37 in.-lb. Remove temporary safety wire, if used.

8. Insert MS3367-5-9 ty-rap through installed clamp and around B283-11 hose assembly. Cinch ty-rap until snug without overtightening and trim ty-rap tip flush with head.
9. Install air intake hose.
10. Install engine cowling assembly and aft seat back assembly.
11. Make appropriate maintenance record entries.
