R44 SERVICE BULLETIN SB-72A
(supersedes R44 SL-24 and R44 SB-72)

DATE: 30 April 2010

SUBJECT: Main Rotor Blade Bond Inspection

ROTORCRAFT AFFECTED: R44 helicopters with C016-2 main rotor blades, and R44 II helicopters with C016-5 main rotor blades.

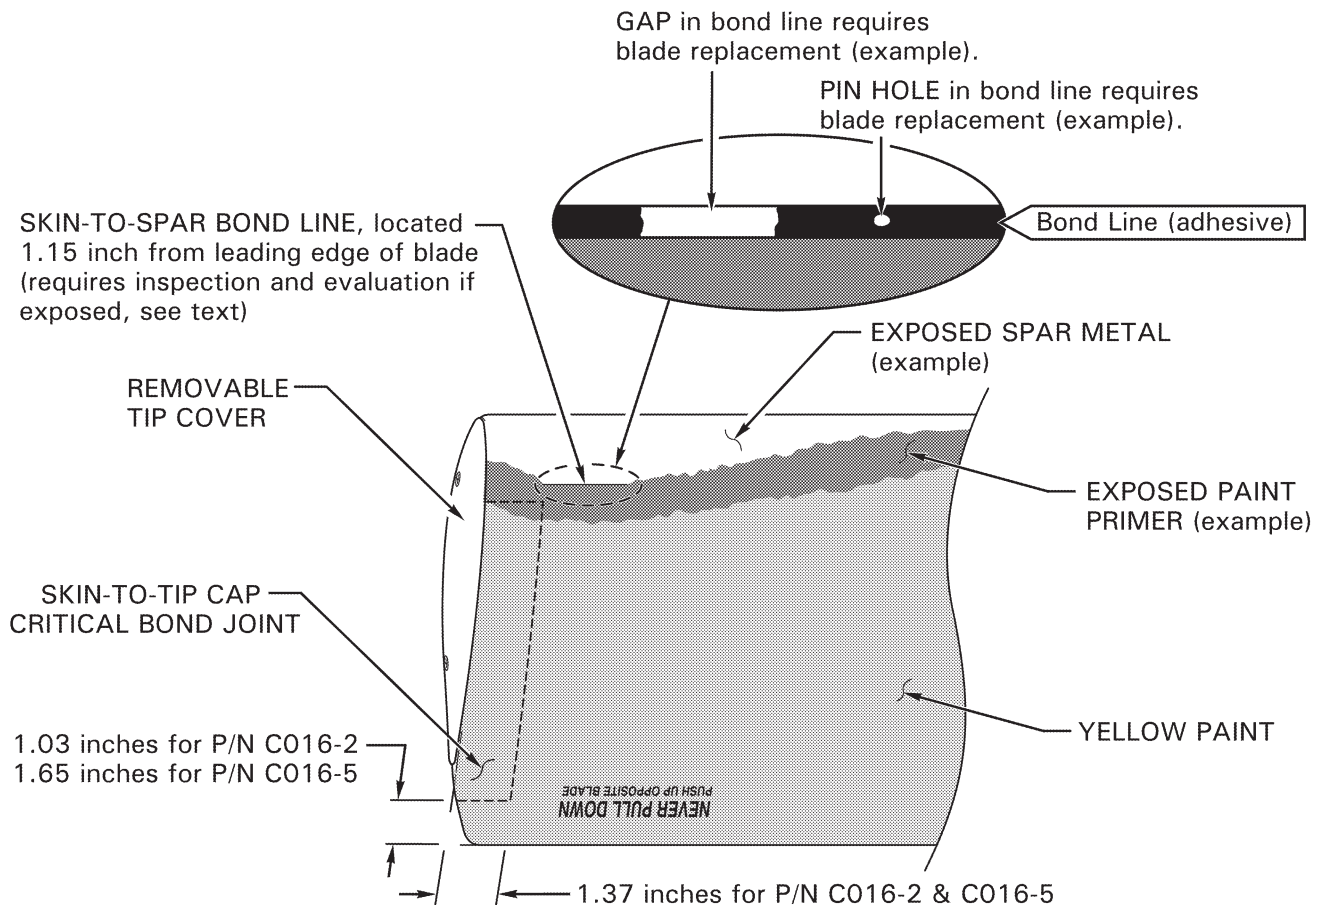
BACKGROUND: Debonding of rotor blade skins can occur when the bond line is exposed due to erosion of the blade finish, or when corrosion occurs on the internal aluminum tip cap. Proper inspection and protection (refinishing) of bonded areas is required. Debonding resulting from improper inspection and maintenance could cause a catastrophic accident.

FIGURE 1 TIP AREA AND LOWER SURFACE
(Example, Blade with Excessive Paint Erosion)

1. Refer to Figures 1 and 2. Remove both main rotor blade tip covers and clean the blades. Clean and remove any corrosion from tip covers.
2. Using 10x magnification, visually inspect uncovered skin-to-tip cap bond joints. Using a 1965-or-later United States quarter-dollar coin, tap test skin-to-tip cap bond joints on both upper and lower surfaces. If corrosion, separation, or voids are detected, blade is unairworthy. A tap test tutorial video is available on our website, www.robinsonheli.com, under the Publications tab.
3. Using 10x magnification, visually inspect any exposed skin-to-spar bond line for gaps (empty space between skin and spar). Blade is unairworthy if any gap, including "pin hole(s)", is detected in the bond line.
4. Refer to Figure 2. Mark outboard 135 inches of blade lower surface as shown to identify skin-to-spar bond joint area.

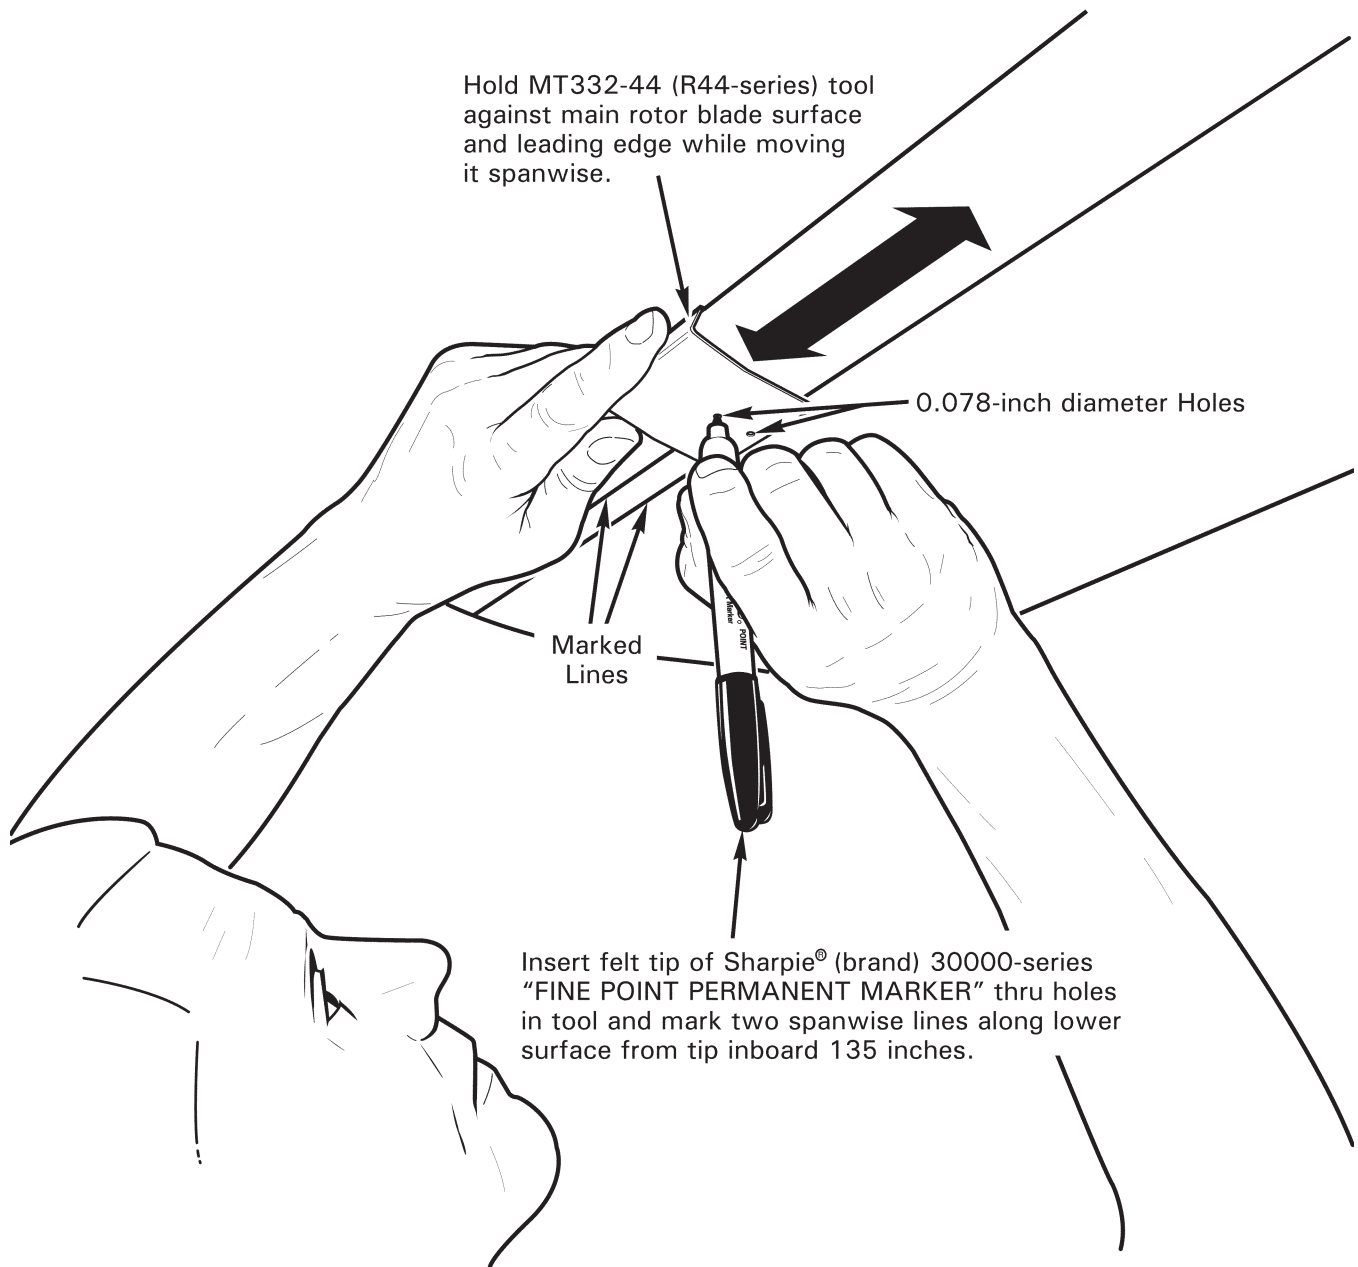
FIGURE 2 MARKING LOWER SKIN-TO-SPAR BOND JOINT AREA

5. Verify no visible dents within the bond joint area. Blade is unairworthy if bond joint area is dented.
6. Tap test the lower skin-to-spar bond joint and verify no voids exist. Blade is unairworthy if a void is detected.
7. Refinish all exposed bare metal, including tip covers, per R44 SL-32B.
8. Install blade tip covers, ensuring cover edges are flush with blade profile.
9. Make appropriate maintenance record entries.
