R44

SERVICE LETTER SL-25

SUBJECT: Hydraulic Reservoir Vent

ROTORCRAFT AFFECTED: R44 Helicopters S/N 1117 and prior equipped with hydraulic flight controls.

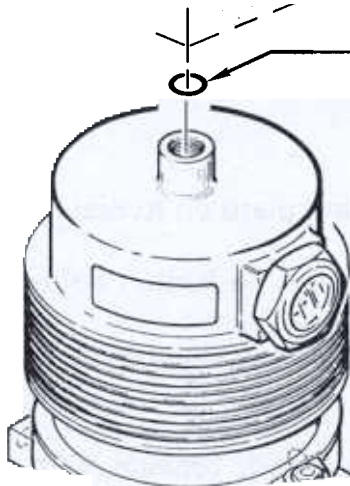
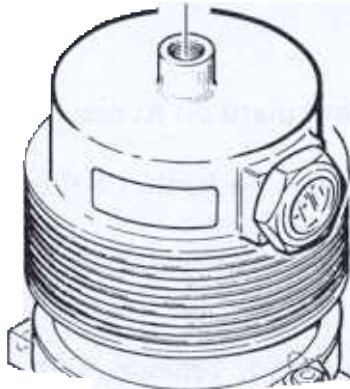
BACKGROUND: RHC has received reports of hydraulic fluid leakage from the reservoir vent. D211 Revision H and subsequent reservoirs have an internal baffle to reduce leakage. Leakage can be reduced on Revision G and prior reservoirs by replacing the standard A610-1 or D487-1 vent with a D487-3 vent.

A610-1 VENT

D487-1 VENT

D487-3 VENT
(REDUCED LEAKAGE
FOR REVISION "G"
AND PRIOR D211
RESERVOIRS)

MS28778-5 PACKING

- 1 Read D211 revision letter from data plate on hydraulic reservoir.
2. For D211 Revision H and subsequent, no further action is required
3. For D211 Revision G and prior, determine which type of vent is installed (see figure on page 2).
4. If A610-1 or D487-1 vent is installed, replace with D487-3 and MS28778-5 packing.
