R44

SERVICE LETTER SL-28

SUBJECT: D040-1 aft cowling assembly

ROTORCRAFT AFFECTED: R44 & R44 II helicopters

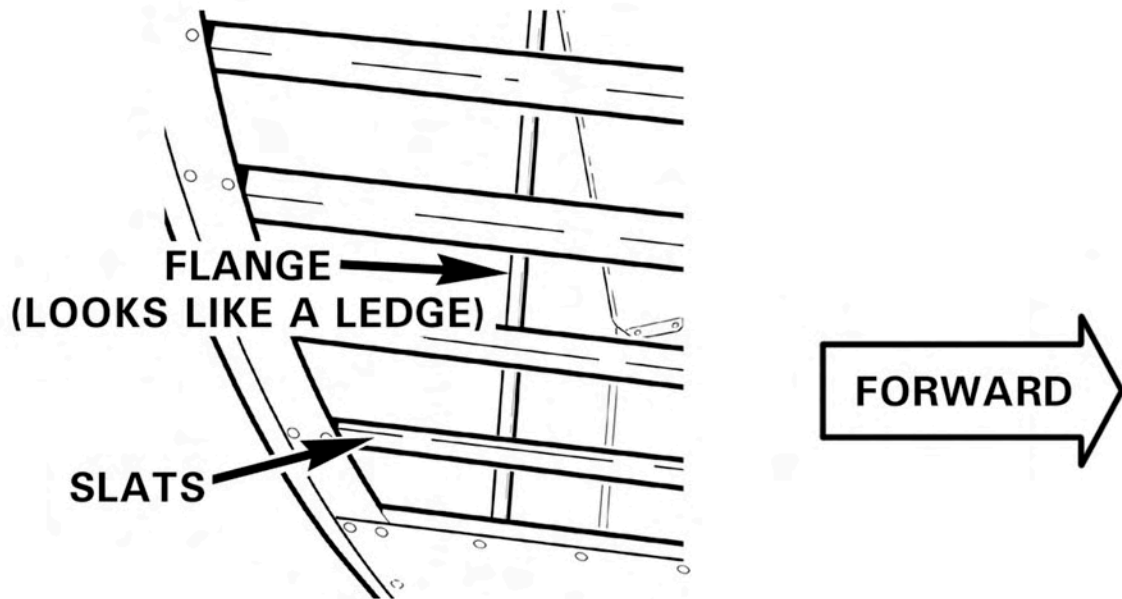
AFFECTED TYPE

BACKGROUND: RHC has received reports of the D040-1 aft cowling's aft, lower aluminum panel cracking. To increase panel flexibility and thereby reduce cracking, later cowling assemblies deleted the stiffening flange between the upper and lower aft panels. Cutting off flange on earlier revision panels will help prevent cracking.

1. Refer to Figures on reverse. Look thru aft cowling's cooling air inlet slats and visually inspect lower aft panel for flange. If flange is present, remove aft cowling.
2. Carefully cut off flange. A powered, high-speed cut-off wheel may be used provided panels are protected from damage via suitably positioned pieces of sheet metal.
3. Blend sharp edges.
4. Inspect panel, especially at edges, for cracks. Minor cracks may be stop-drilled and repaired with doubler(s) in accordance U.S. FAA AC 43.13-1B.
5. Touch-up bare metal with zinc-chromate or epoxy primer.
6. Install cowling.
7. Make appropriate maintenance record entries.
