R44

SERVICE LETTER SL-29

DATE: 15 October 2004

ROTORCRAFT AFFECTED: R44 & R44 II helicopters with optional four-point front-seat harnesses having detachable shoulder straps. Helicopters with standard combination lap belt and diagonal shoulder harness are not affected.

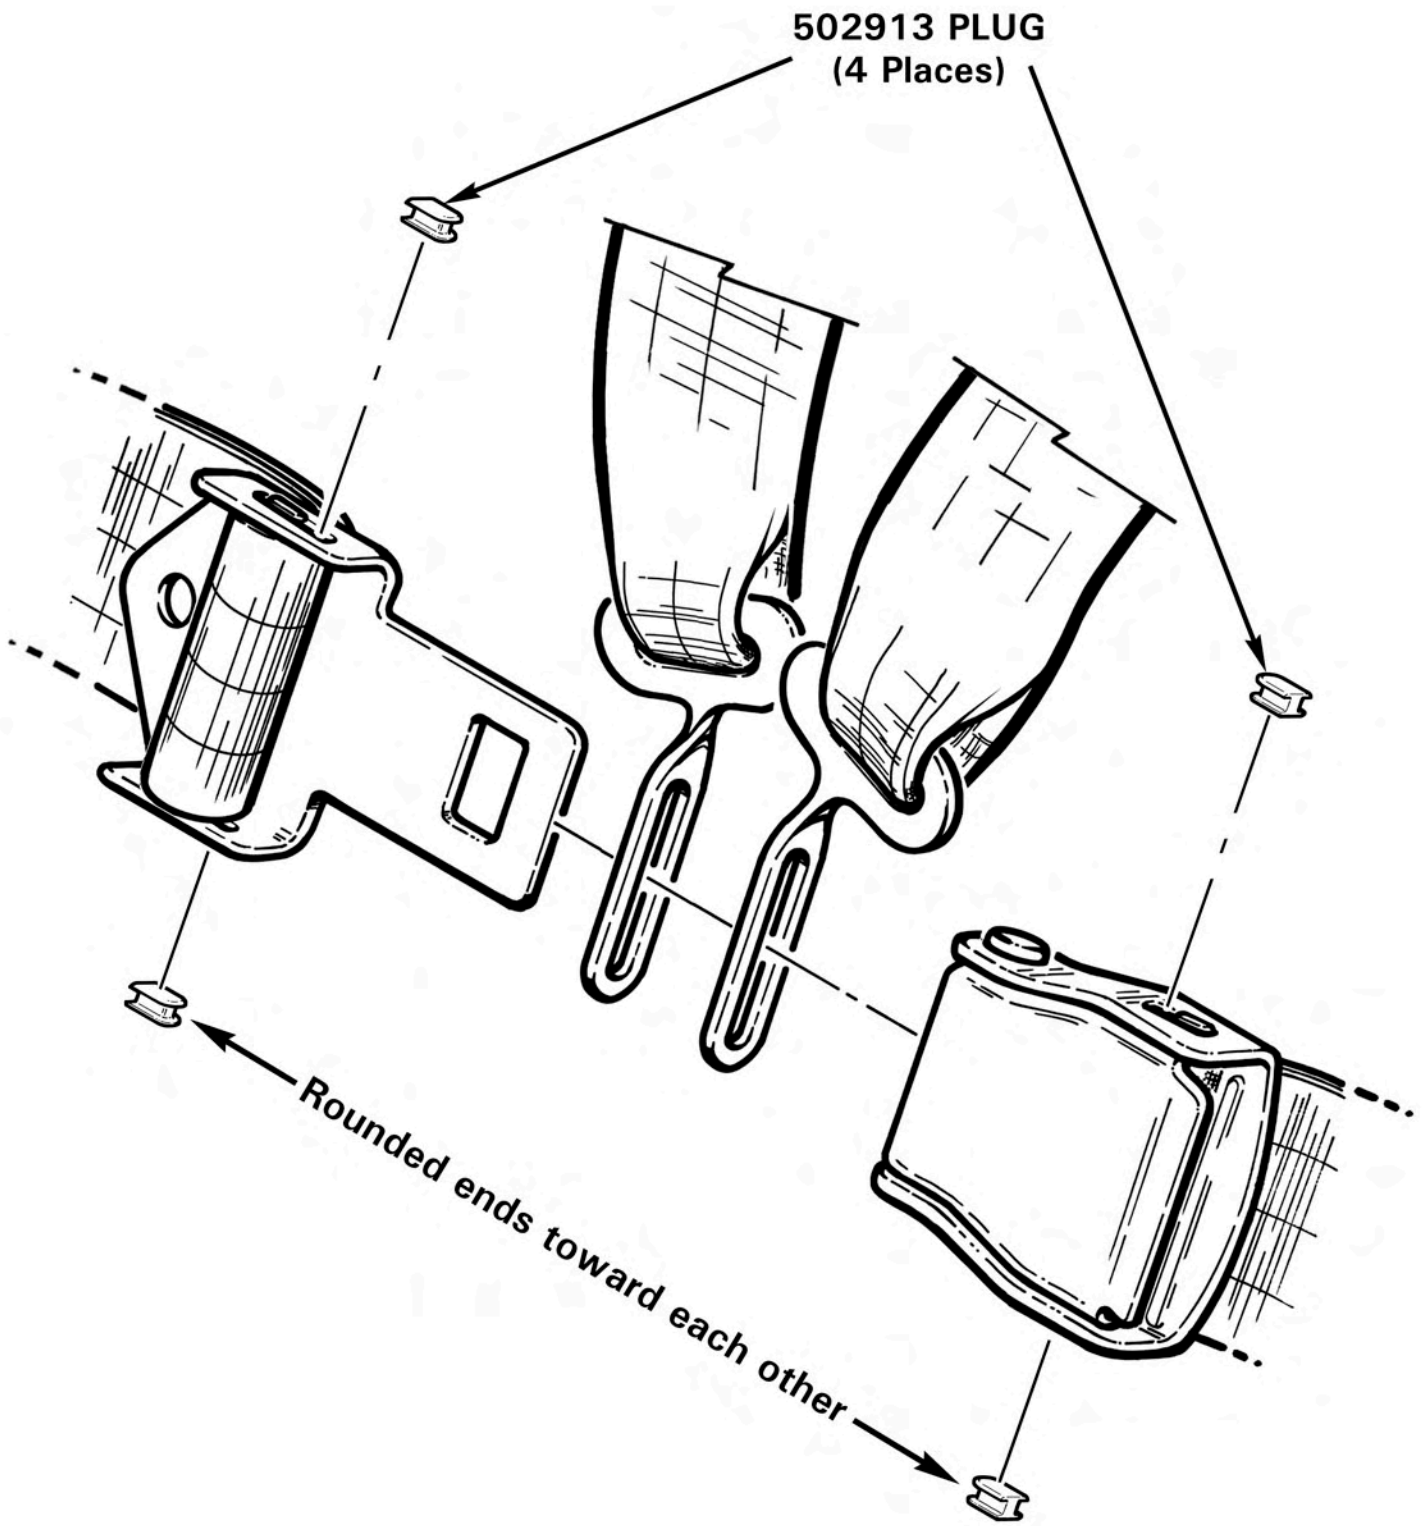
BACKGROUND: Some operators have noticed lap belt loosening on four-point harnesses with detachable shoulder straps. Installing rubber plugs on the lap belt buckle and connector will help prevent lap belt loosening.

1. Refer to figures on reverse. Examine front-seat harness connector and buckle assemblies for presence of black, rubber plugs (2 each on both connector and buckle).
2. As required, order 502913 plugs from RHC Customer Service. Eight plugs are required per affected R44.
3. Install plugs in slots per Figure 1. Exercise care to prevent damage to plug and metal buckle & connector. The rounded end of a paper clip can be used as an installation tool.
4. Make appropriate maintenance record entries.
