R44 SERVICE LETTER SL-40

DATE: 07 September 2011

SUBJECT: MRGB Oil Level Fluctuation

ROTORCRAFT AFFECTED: R44 helicopters S/N 2065 thru 2121, and R44 II helicopters S/N 12848 thru 13127, unless previously accomplished.

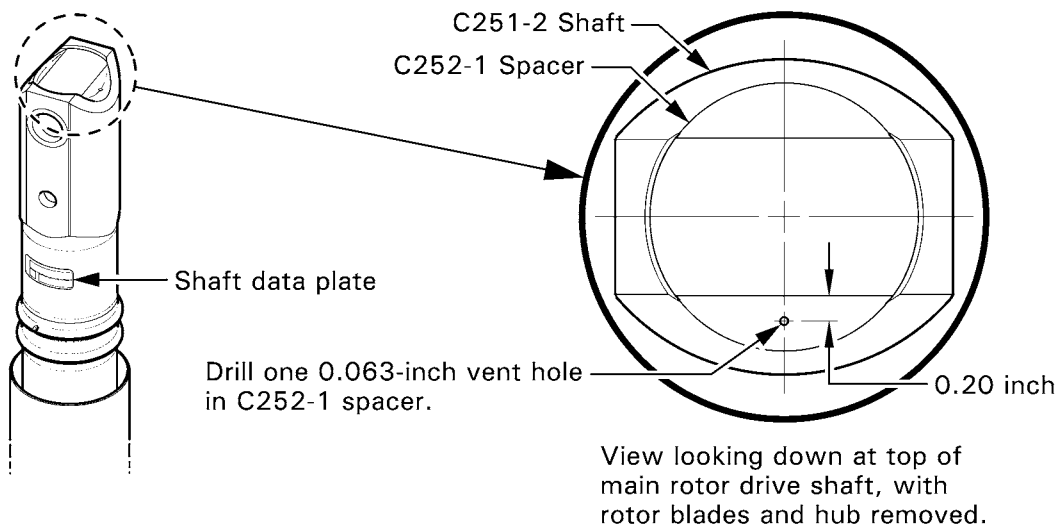
FIGURE 1

BACKGROUND: RHC has received reports of oil level fluctuating in main rotor gearboxes with sealed drive shafts. During cooling after flight, low pressure inside a sealed shaft may draw oil up into the shaft and affect oil level indication. If oil level fluctuates, a vent hole may be drilled in the aluminum spacer at the top of the shaft to equalize pressure.

1. Refer to Figure 1. If data plate indicates C251-2 shaft is revision P (or subsequent), or if C251-2 revision O (or prior) shaft's data plate is marked with a yellow paint dot, the recommendations of this letter have been complied with and no further action is necessary.

4. Refer to Figure 1. Mark hole location in C252-1 spacer as shown; remove sealant as required.
5. Vacuum debris while drilling and slowly drill 0.063-inch diameter hole thru spacer (material is 0.060 inch thick aluminum; adjust drill stop accordingly).

6. Mark shaft data plate with yellow paint dot in upper left corner.
7. Install main rotor hub per MM § 9.122.
8. Install main rotor blades per MM § 9.112.
