R66 SERVICE BULLETIN SB-04

SUBJECT: Oil Cooling Fan Inlet Clearance

ROTORCRAFT AFFECTED: R66 helicopters S/N 0004 thru 0061, 0063 thru 0074, 0076 thru 0080, 0082 thru 0096, 0098, 0100, 0102 thru 0107, 0110, 0111, 0113, 0115, 0117, and 0121.

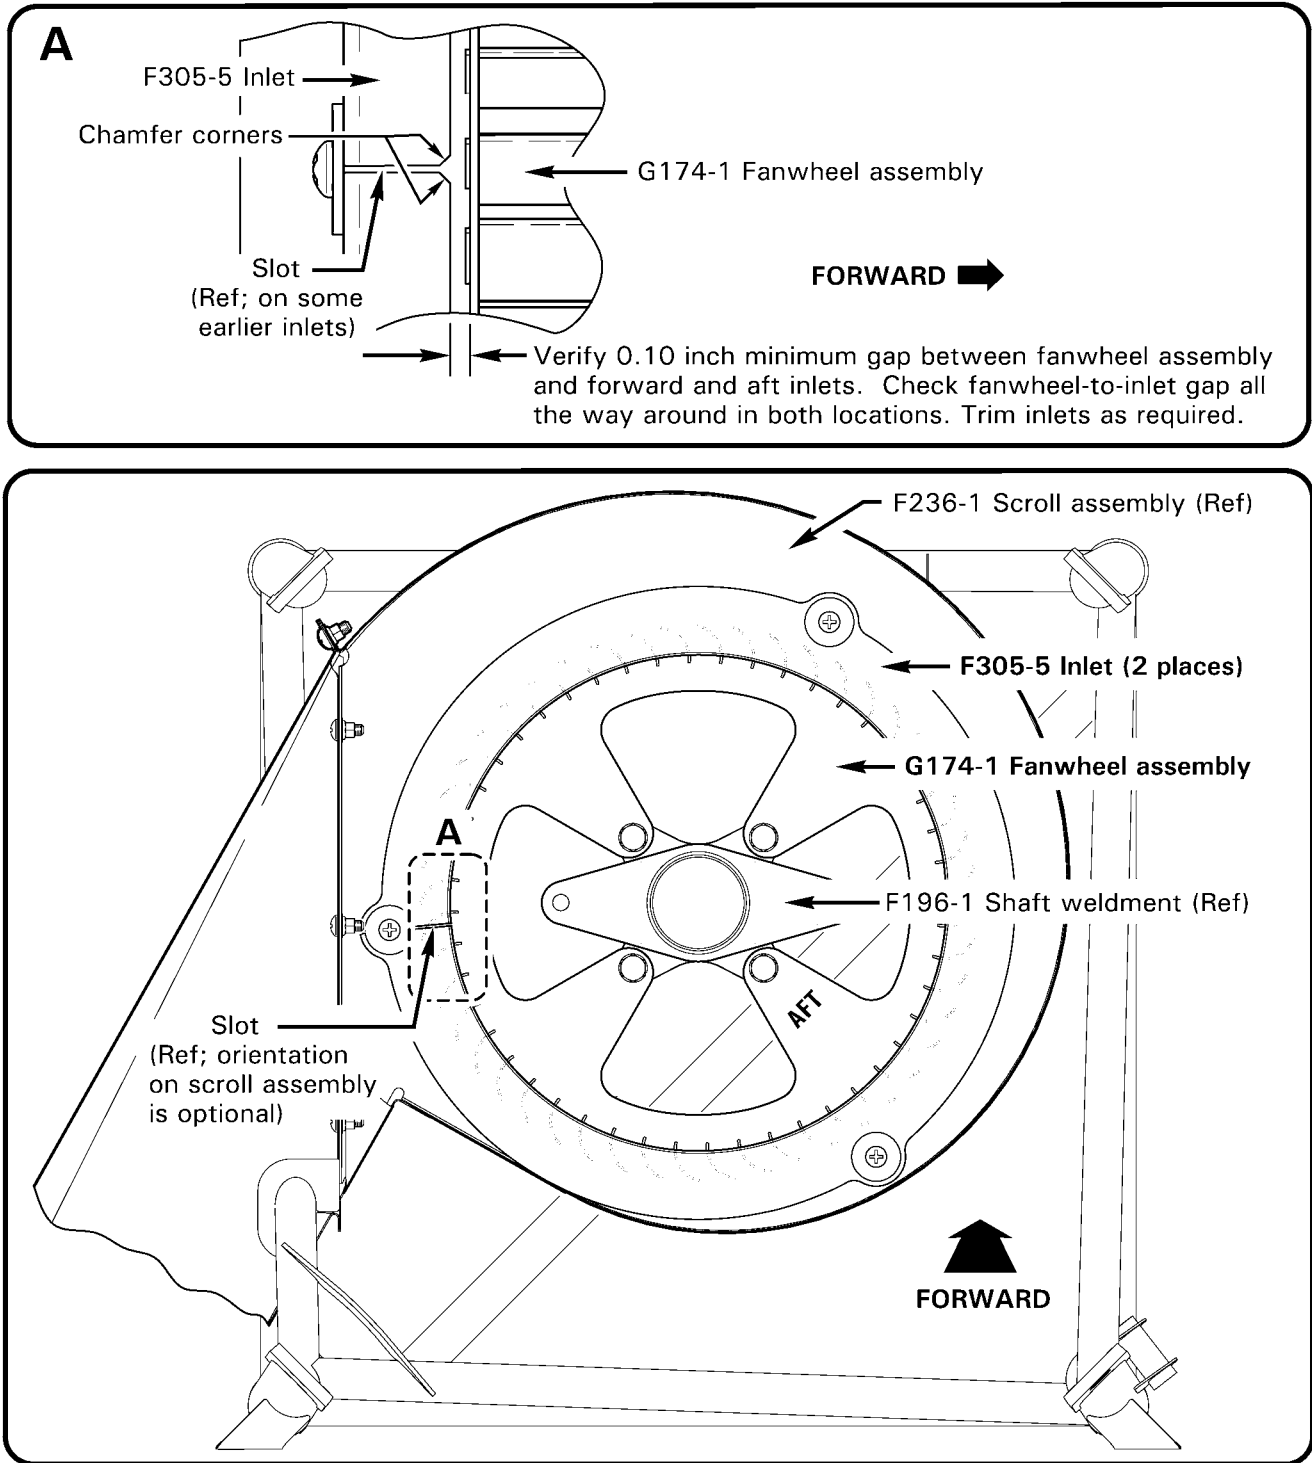
FIGURE 1

BACKGROUND: RHC received an engine cooling fanwheel that separated from the fan shaft during flight. The fanwheel's ring plates were worn due to rubbing against the scroll inlets. This bulletin requires trimming inlets as necessary to ensure a sufficient fanwheel-to-inlet gap.

1. Remove tailcone cowling per R66 Maintenance Manual (MM) § 53-23.
2. Refer to Figure 1. Verify 0.10 inch minimum gap between G174-1 fanwheel assembly and forward and aft F305-5 inlets. Check gap all the way around; rotate fanwheel and check gap again (several positions). If gap is within limits at forward and aft inlets, proceed to step 7.

3. Remove hardware securing inlet(s) to F236-1 scroll assembly. If inlets are slotted, carefully twist inlets over F196-1 fan shaft to remove them. If inlets are not slotted, cut slot in inlets using tin snips per Figure 1 (it is not necessary to disconnect drive train). Straighten part as required. Chamfer slot corners near radius as shown.

4. Refer to MM § 20-70. Trim inlets as necessary to meet minimum fanwheel-to-inlet gap. Smooth inlet edges, deburr new slot edges, and coat bare metal with primer. Touch-up primed area using dark gray polyurethane enamel in accordance with paint manufacturer's recommendations.

5. Carefully twist inlets over fan shaft (slot orientation after installation is not critical). Install hardware securing inlets to scroll. Verify security.

6. Measure fanwheel-to-inlet gap per step 2. Repeat procedure as required for minimum 0.10 inch gap at forward and aft inlets.
7. Install tailcone cowling per MM § 53-23.
