R66 SERVICE BULLETIN SB-20B
(supersedes R66 SB-14 and R66 SB-20A)

SUBJECT: Tail Rotor Drive Shaft Bearings

ROTORCRAFT AFFECTED: R66 Helicopters S/N 0003 thru 0752. Spare D224-3 tail rotor drive shafts are also affected. Spare D224-4 tail rotor drive shafts are affected by part B only.

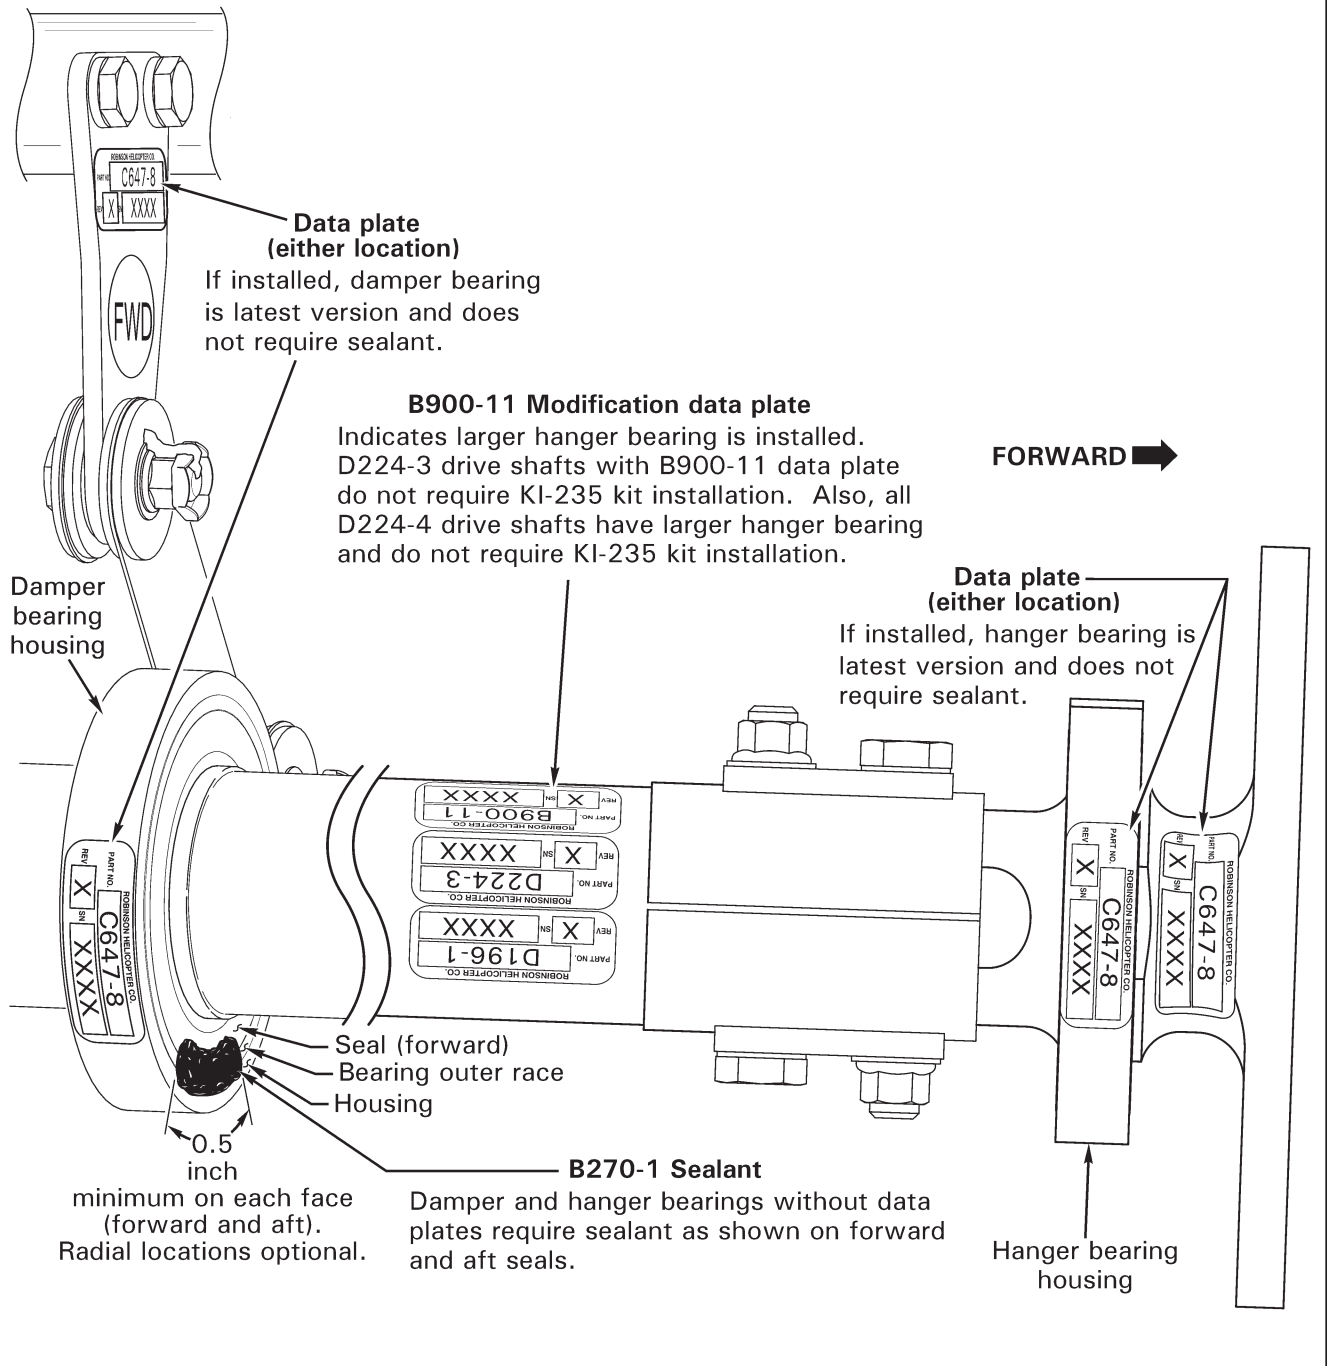
FIGURE 1

Refer to Figure 1. If a data plate is installed on the C041-13 arm or damper bearing housing, then the damper bearing is latest version and no sealant is required; if a data plate is installed on the D195-3 yoke or hanger bearing housing, then the hanger bearing is latest version and no sealant is required. Bearings without data plates require sealant per the following:

1. Refer to Figure 1. If a D224-3 tail rotor drive shaft assembly **without** a B900-11 modification data plate is installed, order one KI-235 bearing upgrade kit from RHC Customer Service and install kit per kit instructions.
2. Remove (pink-colored) Special Pilot Caution for R66 SB-14, dated 25 June 2015, from Pilot's Operating Handbook.
3. Make appropriate maintenance record entries to reflect compliance with Part A of this bulletin. No change to helicopter weight and balance.

3. As applicable, clean accessible portion of bearings lacking sealant with cotton swabs dampened with acetone. Using a smooth, rounded tool of sufficient length, apply a minimum 0.5 inch long bead of B270-1 sealant at most accessible junction of seal and bearing outer race; sealant contact with housing is permissible. Allow sealant to cure. Sealant is required on both bearing faces (forward and aft).
