R66 SERVICE BULLETIN SB-23

SUBJECT: Rod Ends for F174-1 Engine Support Weldment

ROTORCRAFT AFFECTED: R66-series Helicopters S/N 0004 thru 0860 except 0018, 0823, 0847, 0858, and 0859.

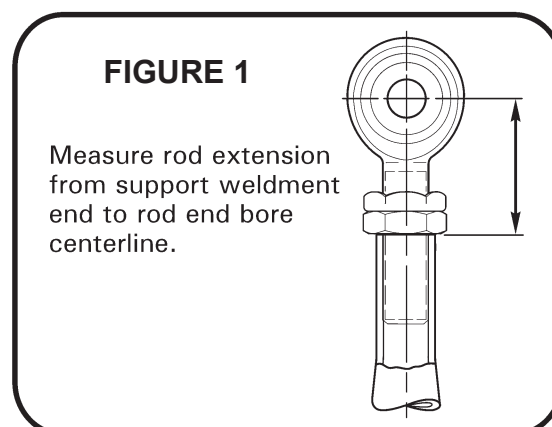
BACKGROUND: During recent flight testing, an intermittent vibration was found in the F174-1 engine support weldment. This bulletin requires installing F101-4 elastomeric rod ends where the support weldment attaches to lower frames.

5. Refer to MM Figure 53-2 Detail B. Remove hardware securing support weldment A101-4 rod ends to F046 lower frames and remove support weldment.
6. Refer to Figure 1. Measure and record distance between support weldment end to A101-4 rod end bore centerline (rod extension), both sides.

- ii. Refer to Figure 1. Adjust rod extension on both sides as required, ensuring rod extension is no more than 1.10 inches.
 - iii. Repeat steps a. & b. until minimum shaft-to-firewall grommet clearance is achieved.
