**R22 SERVICE BULLETIN SB-114**

**DATE:** 25 February 2019

**SUBJECT:** D602-3 Time Delay Assembly

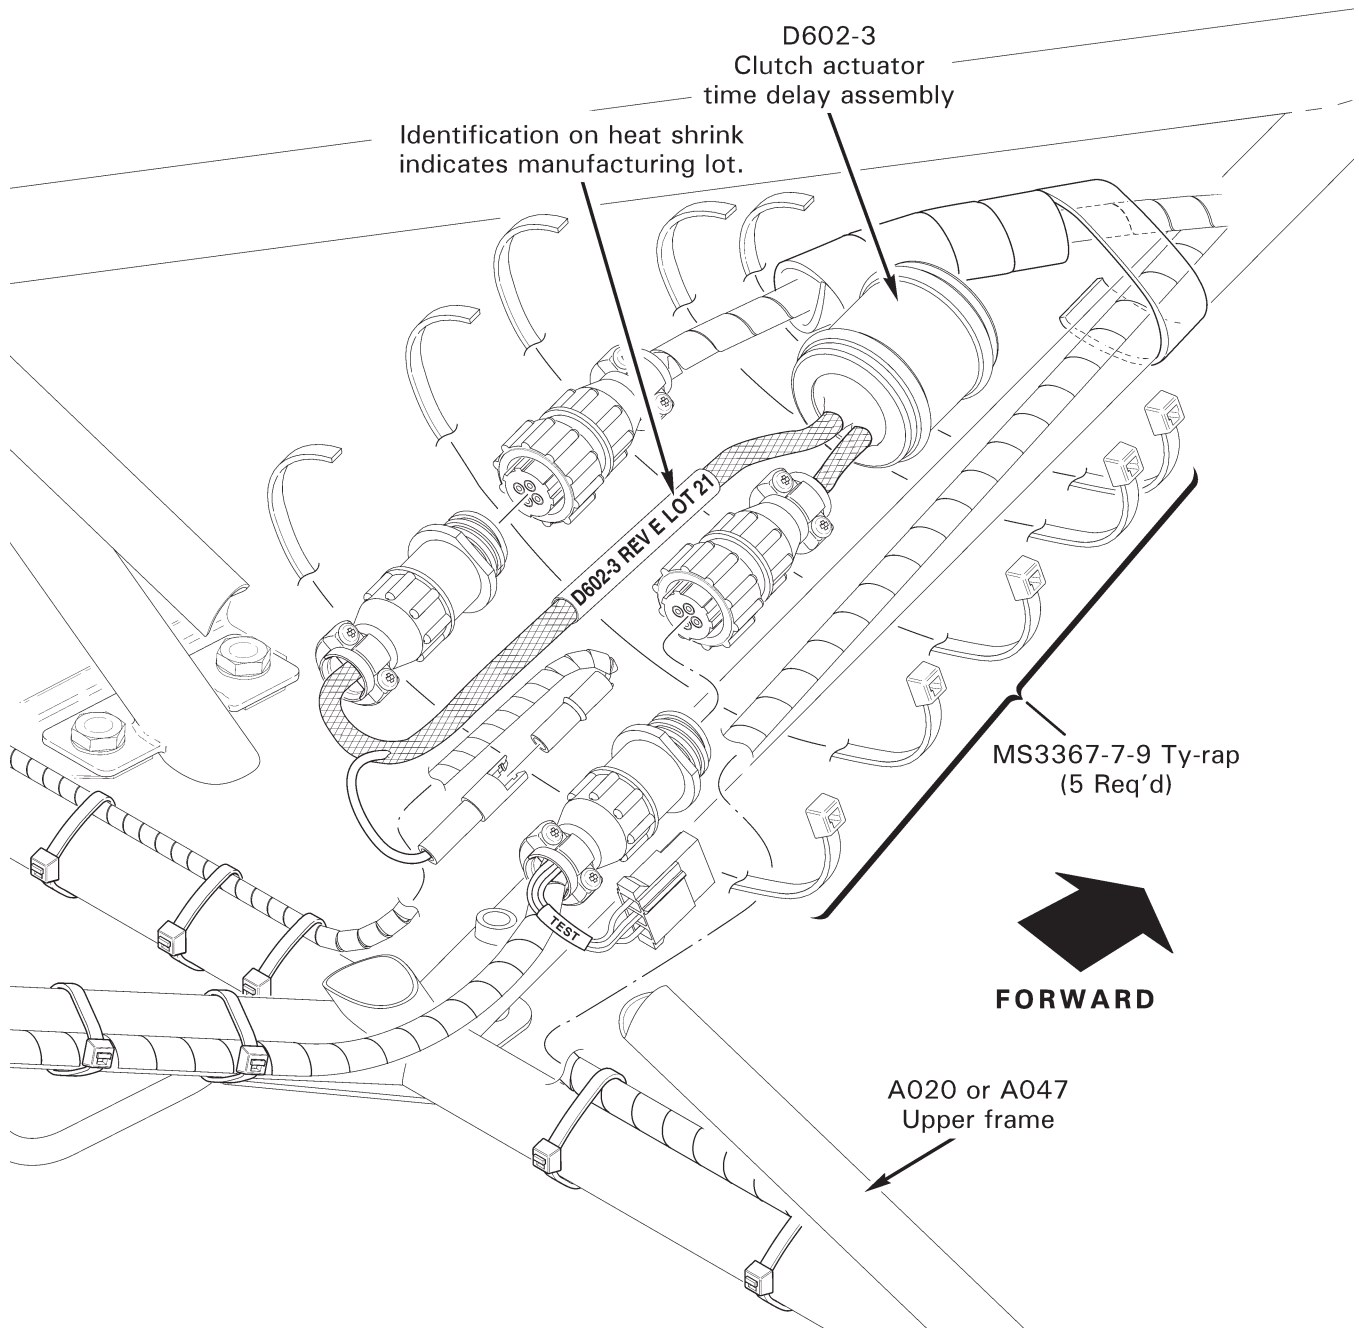
**FIGURE 1**

**BACKGROUND:** RHC has determined that Lots 14 thru 21 of D602-3 Time Delay Assemblies for the clutch actuator may have been assembled with an incorrect resistor. These time delays must be replaced to ensure long-term reliability.

1. Refer to Figure 1. Determine Lot number of installed D602-3 time delay assembly. (Cut ty-raps as required to access identification marking.) If Lot number is not 14 thru 21 the time delay is unaffected; replace cut ty-raps and proceed to step 3.
2. If Lot number is 14 thru 21, or if Lot number cannot be determined, install an unaffected time delay per KI-242 instructions.
3. Make appropriate maintenance record entries.
