R44 SERVICE LETTER SL-69

R66 SERVICE LETTER SL-29

SUBJECT: C627-6 Five-point Harness Assembly Lower Strap

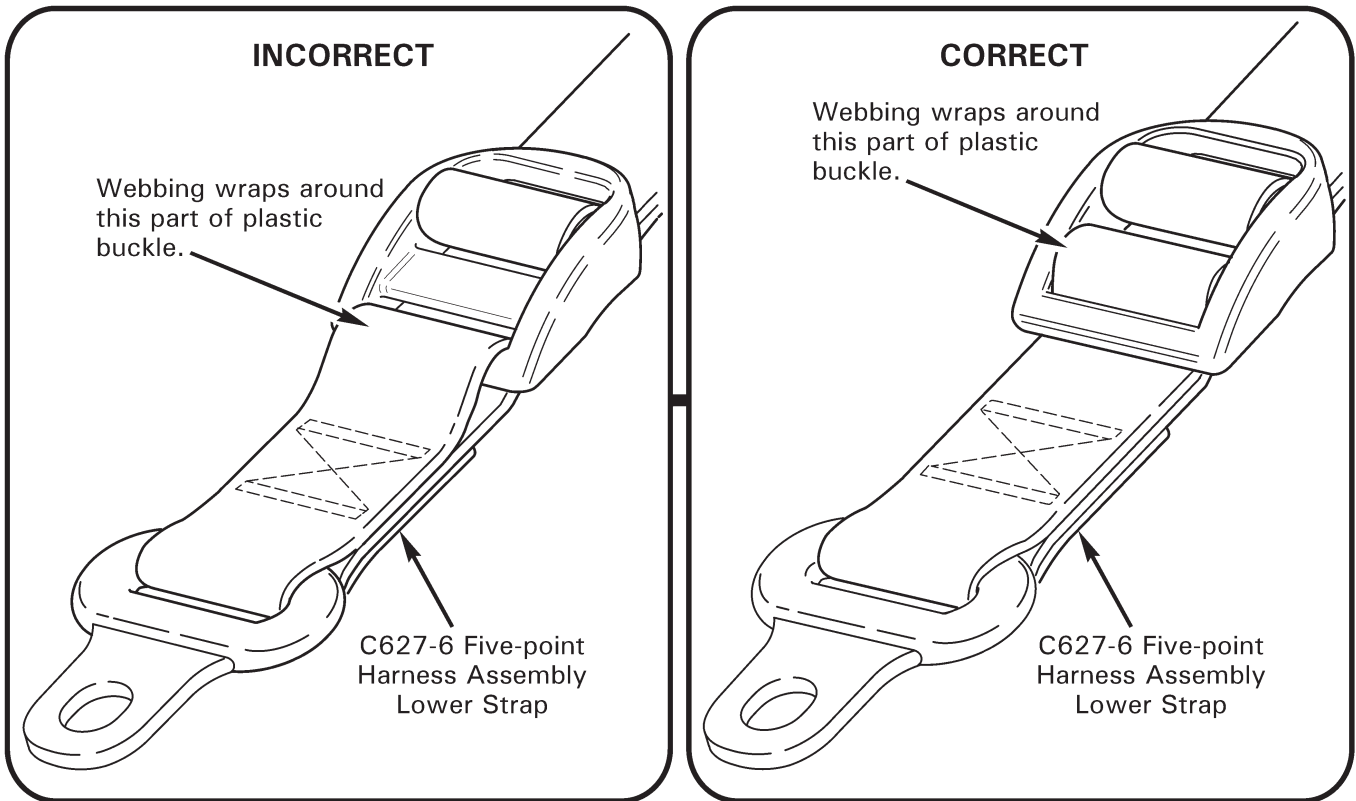
FIGURE 1

BACKGROUND: RHC has determined that the plastic adjusting buckle on the lower strap of C627-6 Five-point Harness Assemblies may have the webbing routed improperly. As a result, tightening the adjustment may crack the plastic buckle. Incorrect parts should be replaced to ensure that proper adjustment is available to the occupants.

1. Refer to Figure 1. If lower strap of C627-6 Five-point Harness Assembly is assembled incorrectly, order one AmSafe p/n 5134-2010111747 Lower Strap from RHC Customer Service.
2. Refer to Figure 2. Remove incorrect lower strap and install correct lower strap using existing hardware as shown. Verify security.
