R44 SERVICE BULLETIN SB-106

R66 SERVICE BULLETIN SB-37

DATE: 21 August 2020

SUBJECT: HeliSAS Autopilot Interface with Garmin PFD

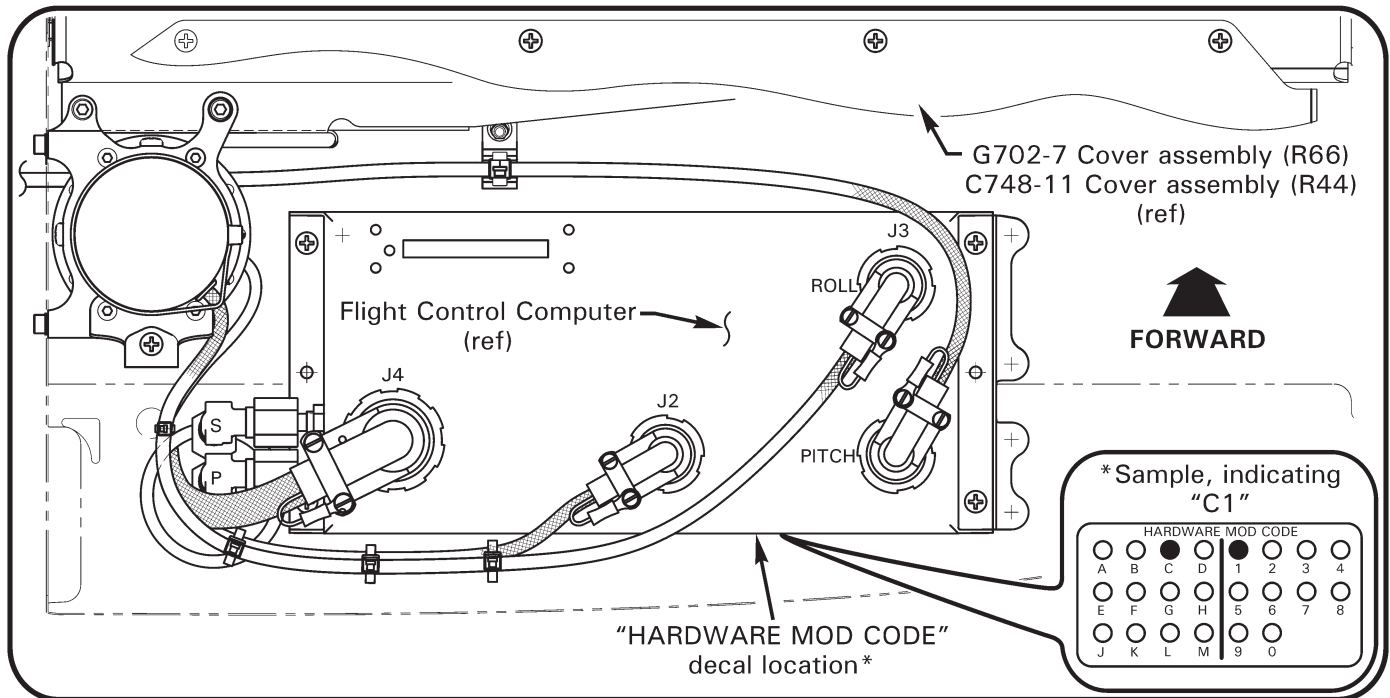
FIGURE 1

- FCC modification at S-TEC requires approximately 2 weeks.
- Modification level of upgraded unit will be indicated on data plate as shown in Figure 1.

Option A: Return FCC to HeliSAS manufacturer S-TEC for upgrade to FCC Mod "B2" or Mod "C1" (resistors will be added inside computer).
