R44 SERVICE LETTER SL-77

DATE: 11 November 2020

SUBJECT: Clutch Actuator Gearmotor Wiring

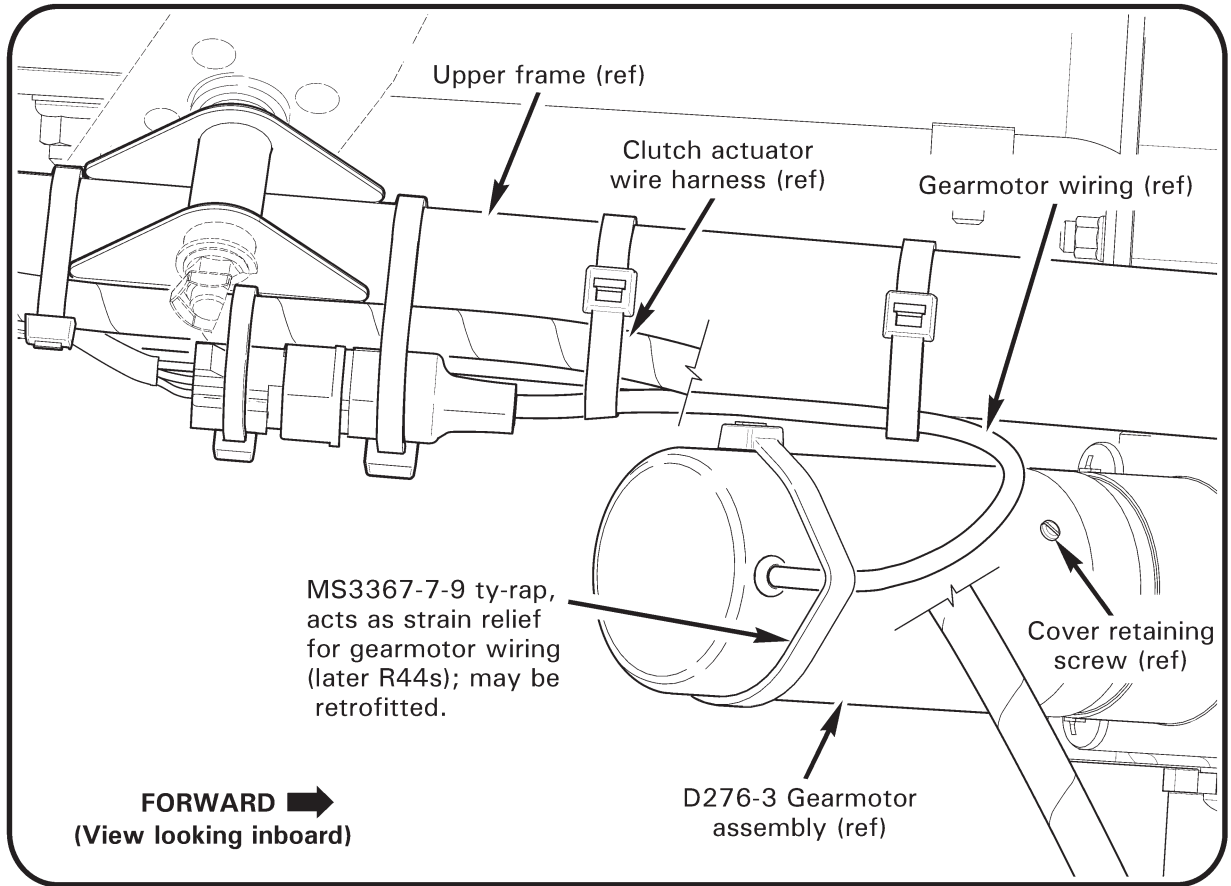
FIGURE 1

BACKGROUND: Clutch actuator gearmotor wiring can be damaged by improper installation. Damaged wiring can affect actuator function and, if heat shrink covering is damaged, may create a path for moisture to corrode the gearmotor.

1. Verify clutch is disengaged. Open right side aft cowl door.
2. Refer to Figure 1. Visually verify gearmotor wiring is not kinked or pinched and exhibits slack between gearmotor and upper frame.
3. Engage clutch. Verify gearmotor wiring exhibits slack. Disengage clutch.
4. If discrepancies are found, have technician closely inspect gearmotor's heat-shrink covered, shielded wiring for damage. Torn heat shrink may be repaired by covering with a sufficient length of B158-704 heat shrink. Damaged wiring may be repairable in accordance with FAA AC 43.13-1B Ch. 11.

If gearmotor cover was removed to facilitate repair, use B270-8 adhesive to seal cover's open end, cover retaining screw, and wiring exit at cover after cover installation.

5. Position gearmotor wiring to provide slack between gearmotor and upper frame. Cinch ty-raps until snug without overtightening and trim tip flush with head.
