R44 SERVICE BULLETIN SB-113

DATE: 16 March 2023

SUBJECT: Actuator Lower Bearing A185 Brackets

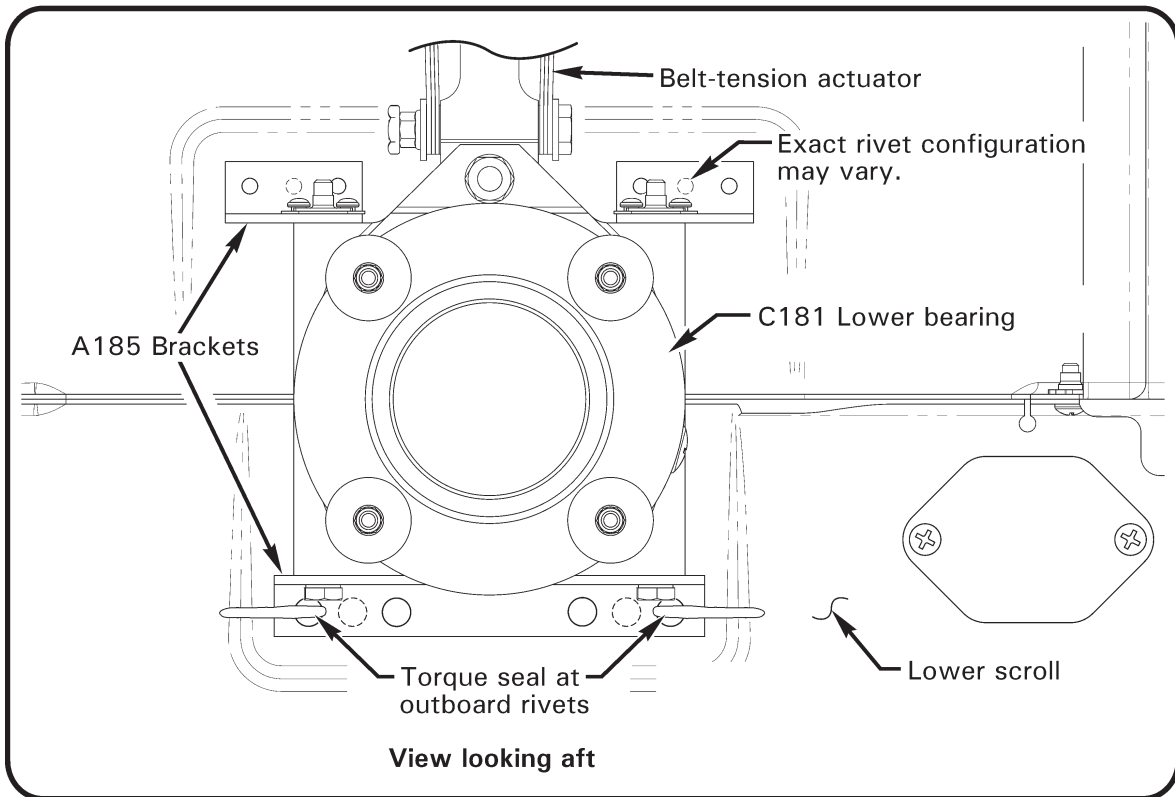
BACKGROUND: Loose A185 brackets may allow the lower bearing housing to misalign resulting in belt-tension actuator damage, followed by possible loss of drive belt tension and subsequent loss of rotor drive. This bulletin requires verifying quantity & size of rivets attaching brackets to scroll, and replacing and/or retrofitting additional rivets if necessary.

1. Refer to Figure on page 2. Visually inspect A185 brackets and verify three 5/32-inch [shank diameter] rivets attach bracket to scroll at each corner of C181 lower bearing (earlier brackets used 1/8-inch rivets and require upgrade). If there are less than (12) 5/32-inch rivets total, or if evidence of bracket looseness or fretting is found, repair scroll per R44 Service Letter SL-61 (latest revision).

2. On lower A185 bracket, remove any previous vertical torque seal, then apply torque seal in a horizontal stripe across both outboard rivets to lower scroll to facilitate future inspections.
